GOLETA WEST SANITARY DISTRICT

FORCE MAIN INSPECTION SUMMARY AND RECOMMENDATIONS

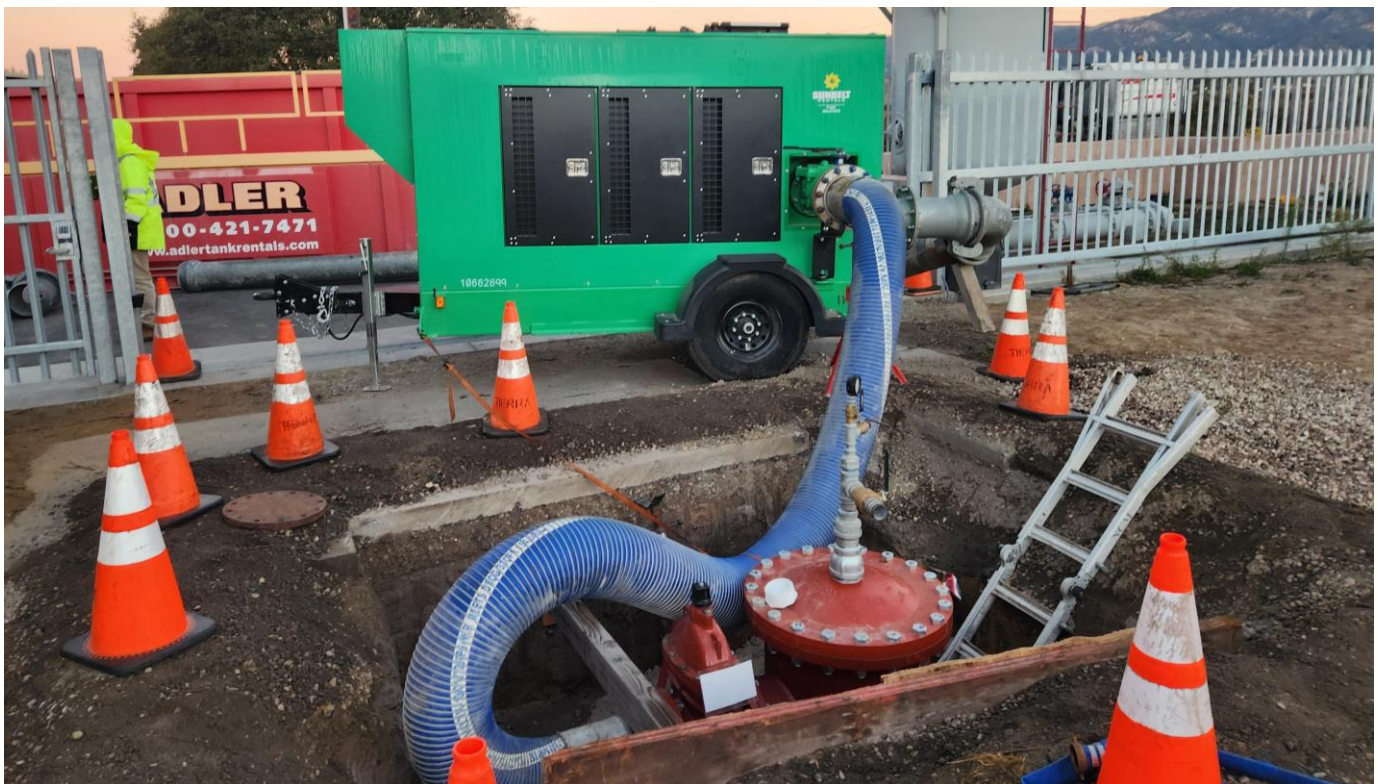
**CONSULTANT****MNS ENGINEERS, INC.****LOCAL OFFICE**201 N. Calle Cesar Chavez, Suite 300
Santa Barbara, CA 93103
805.692.6921 Office**PROJECT CONTACT****Nicholas Panofsky, P.E., Vice President – Water Resources**
805.592.2074 mobile | npanofsky@mnsengineers.com

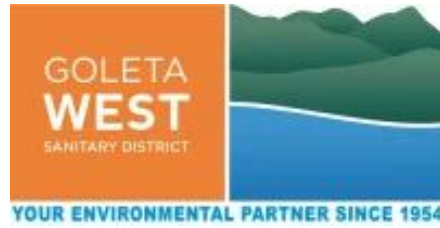
FORCE MAIN INSPECTION SUMMARY AND RECOMMENDATIONS

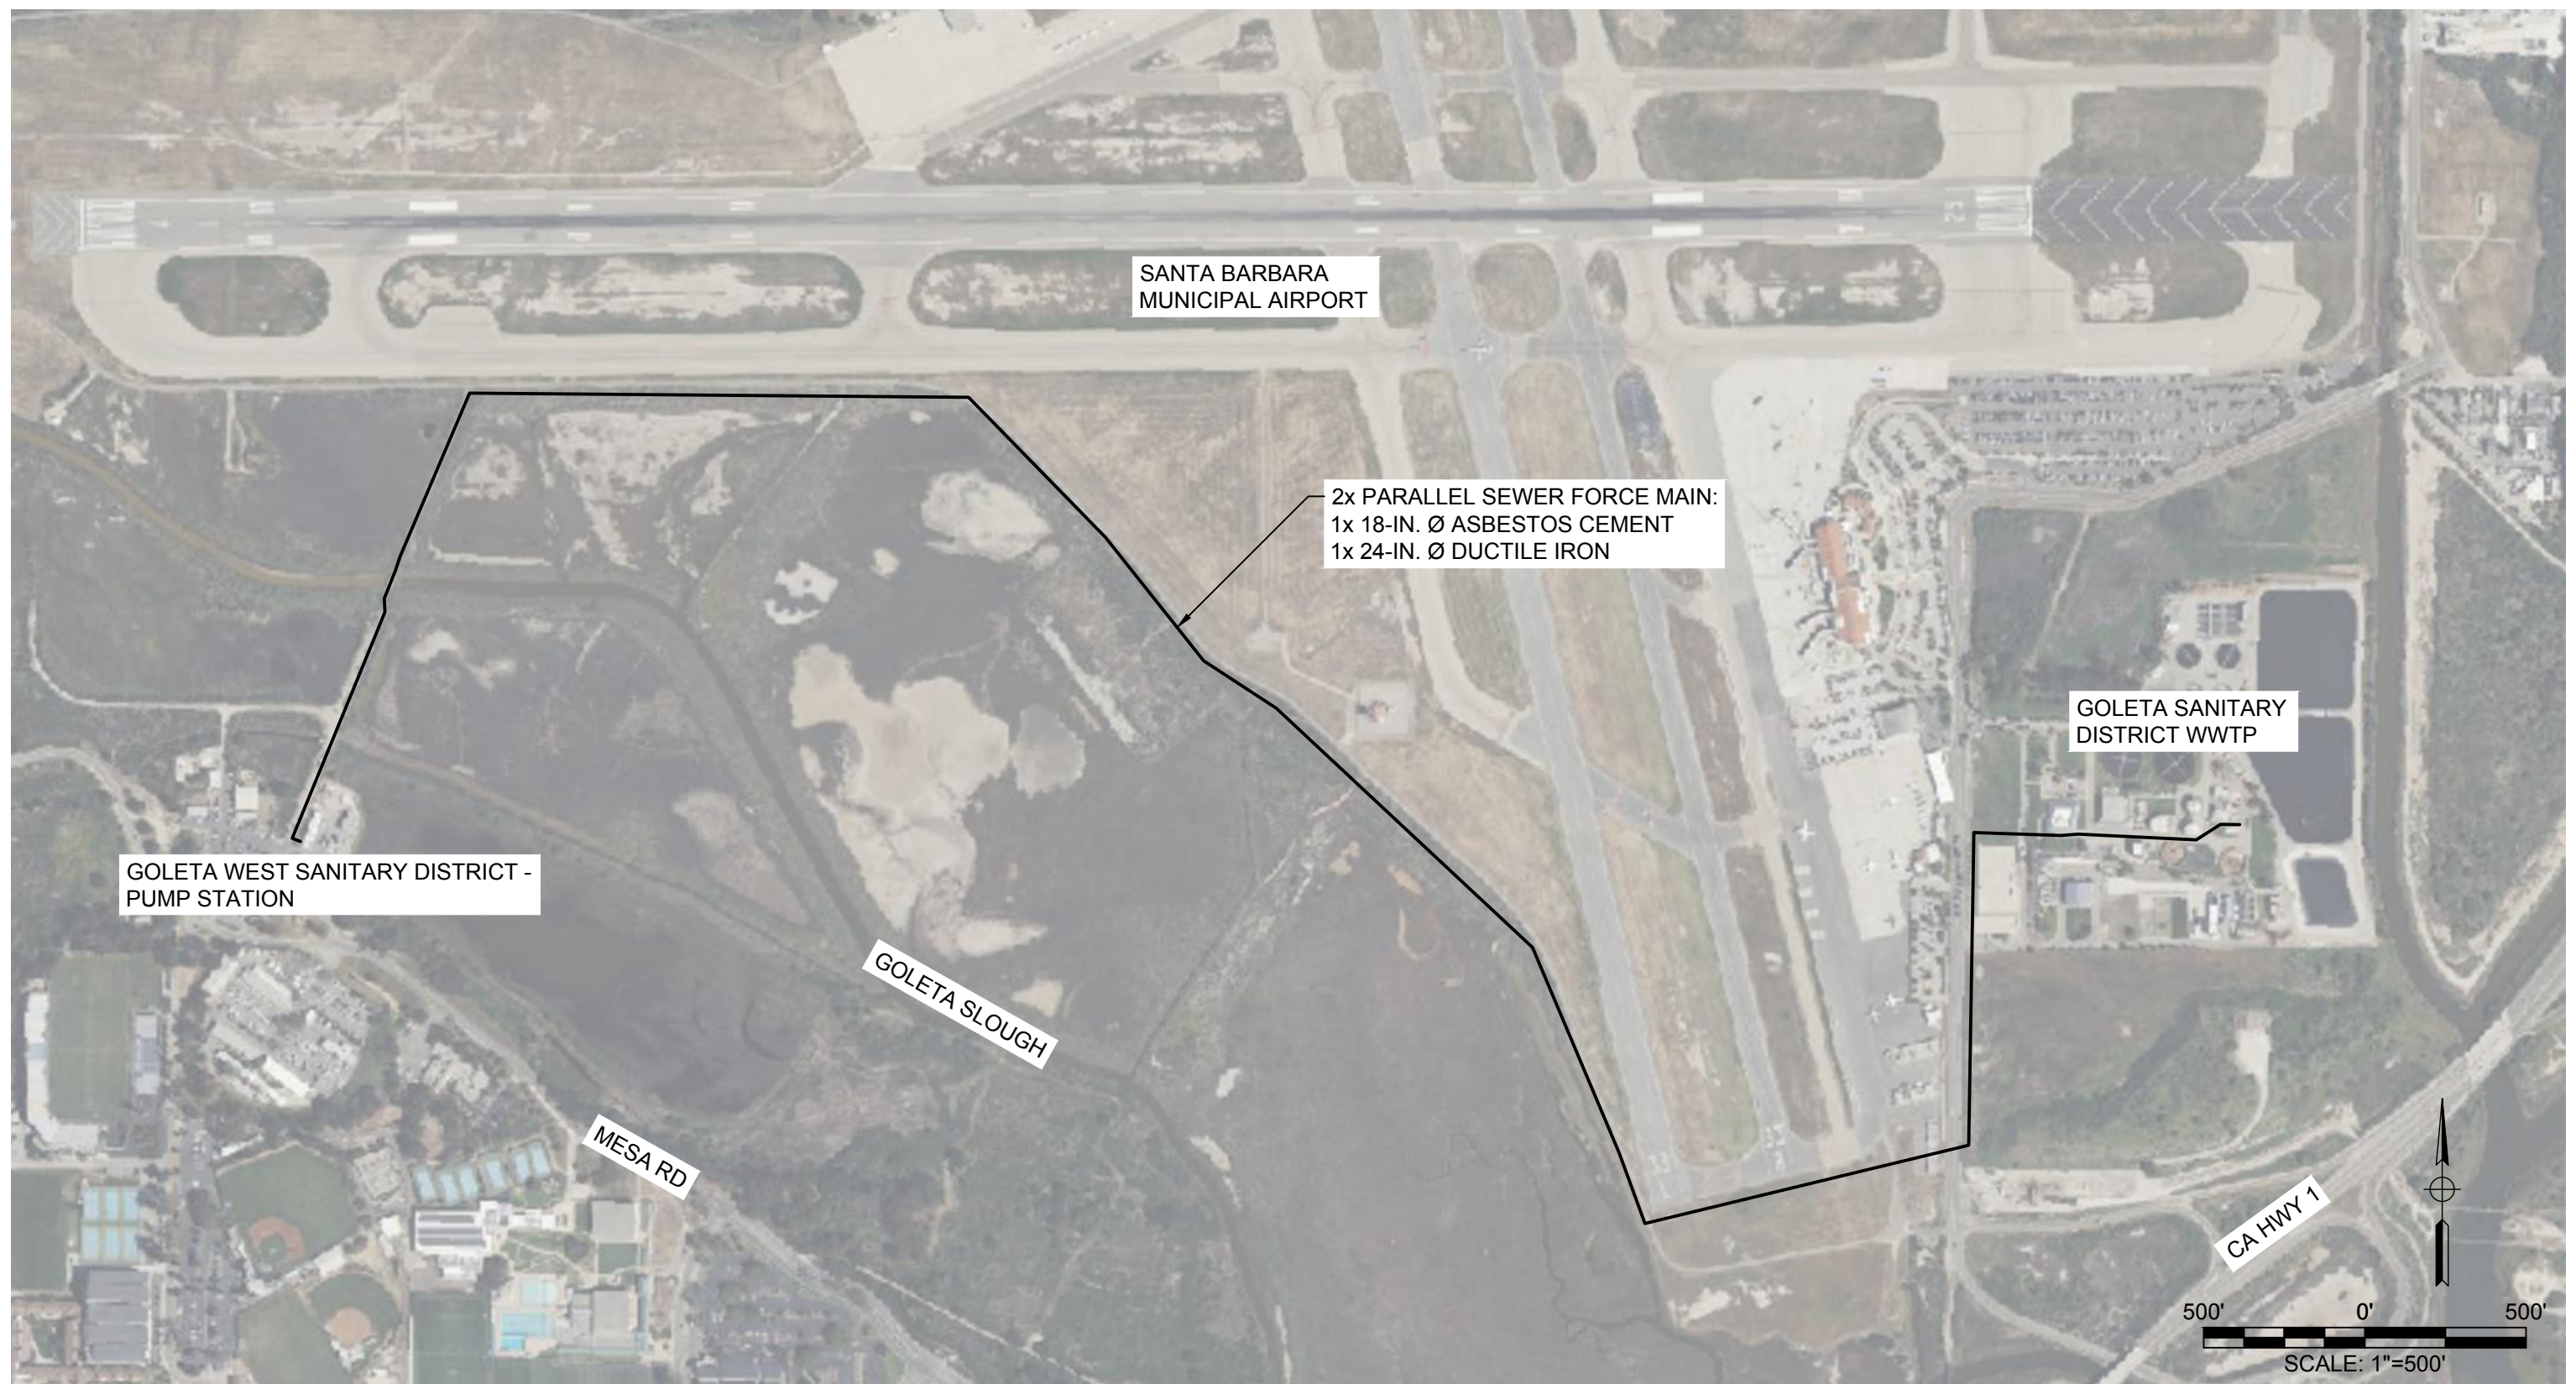
EXISTING FORCE MAINS ALIGNMENT
FORCE MAIN INSPECTION SUMMARY AND RECOMMENDATIONS
GOLETA WEST SANITARY DISTRICT

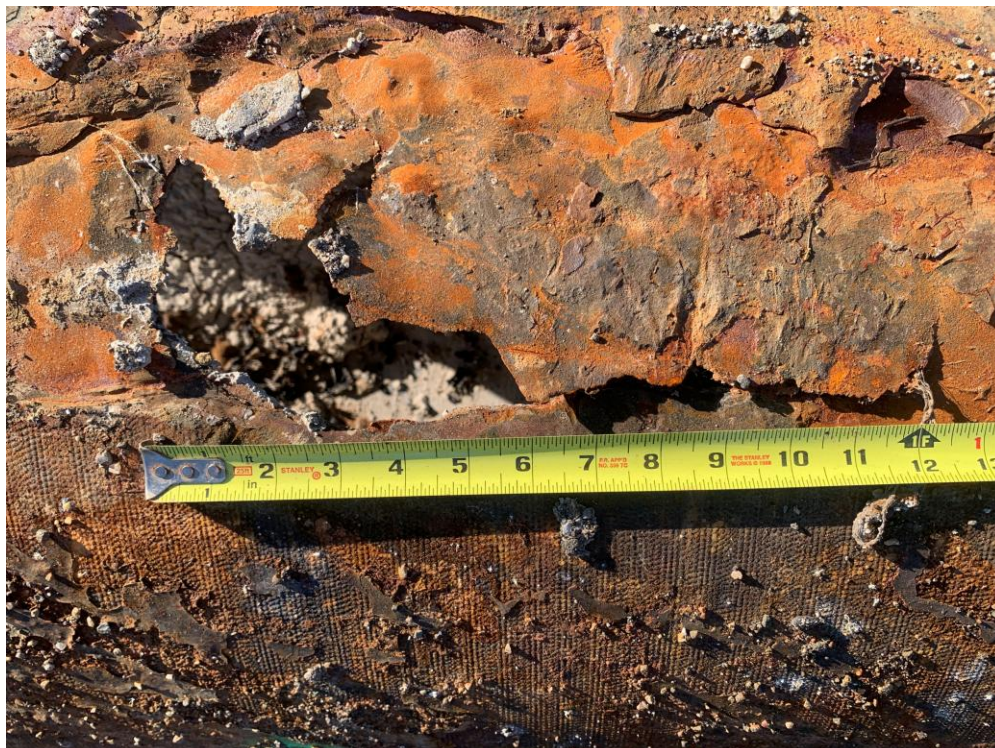
Figure 1-2. Ductile iron pipe section removed from the February 2024 spill site. Entire sections of pipe wall had deteriorated, revealing the inside of the pipe behind.

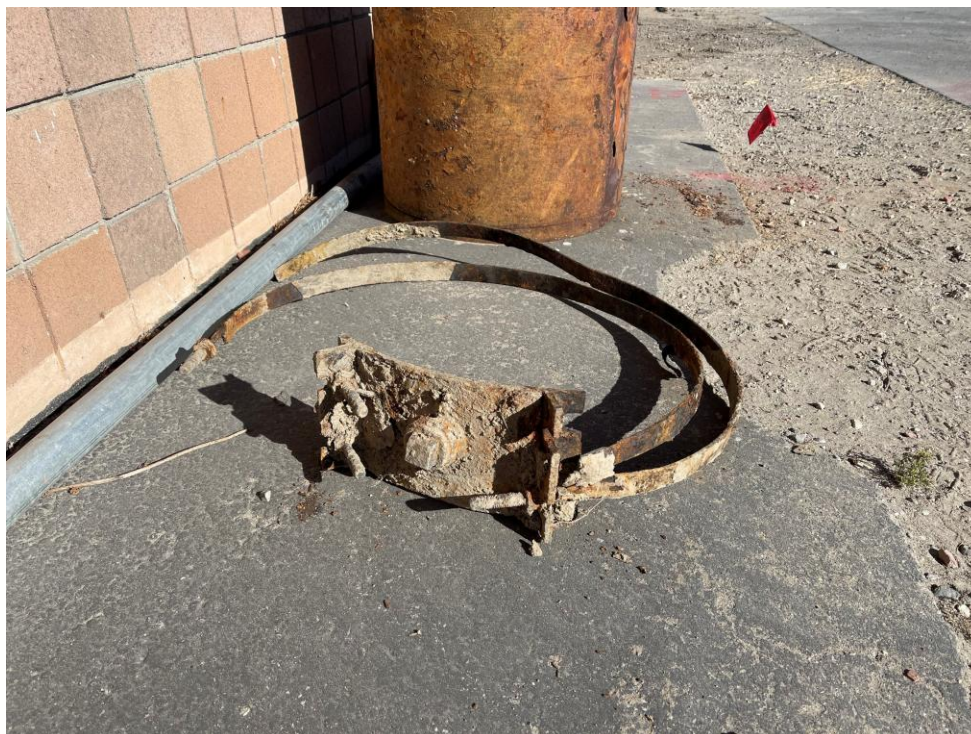
Figure 1-3. Failed ductile iron pipe hot tap adapter removed from the October 2024 spill site

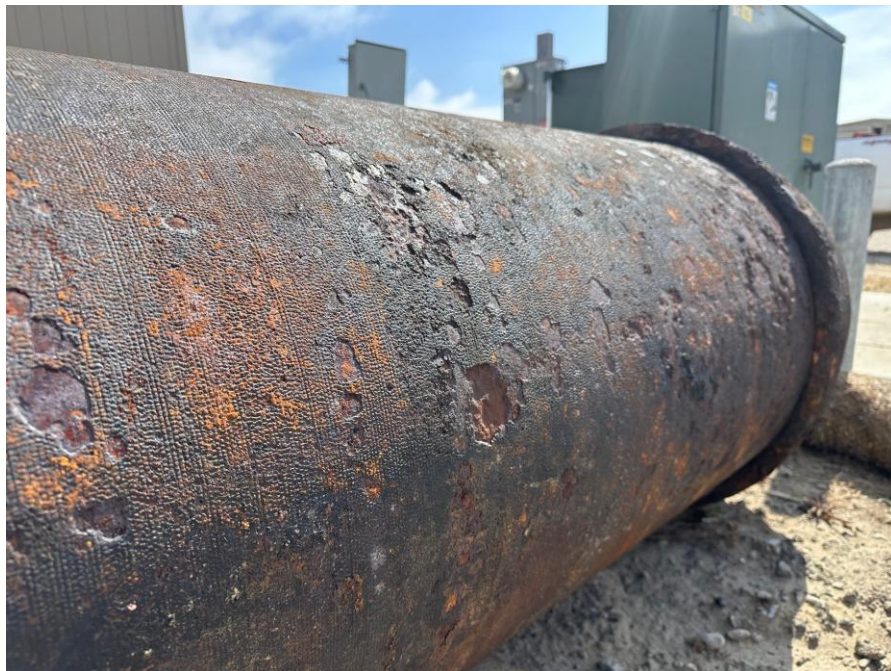
Figure 2-3. Corroded segment of ductile iron pipe removed per Xylem's dig sheet recommendations – Photograph 1 of 2.

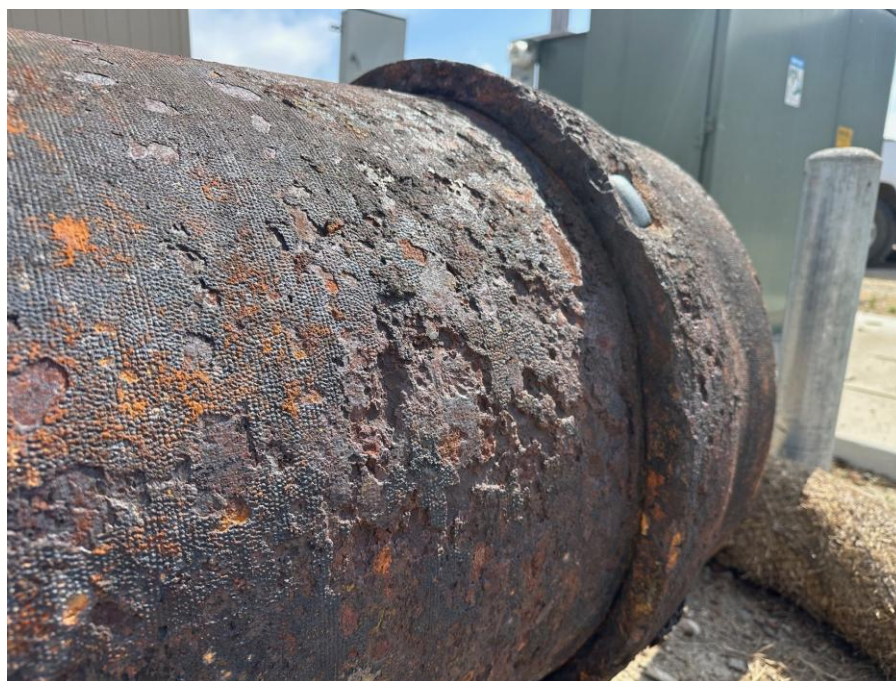
Figure 2-4. Corroded segment of ductile iron pipe removed per Xylem's dig sheet recommendations - Photograph 2 of 2

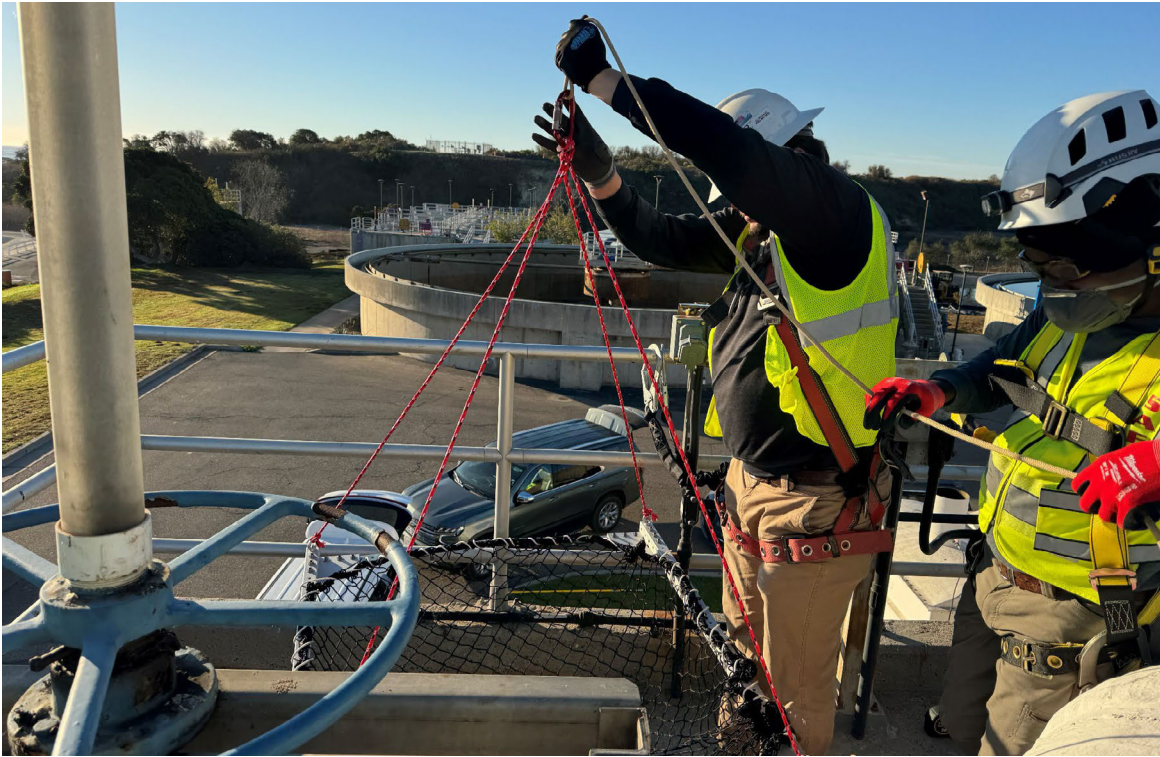
Figure 2.2: SmartBall Extraction Net Being Placed into Position

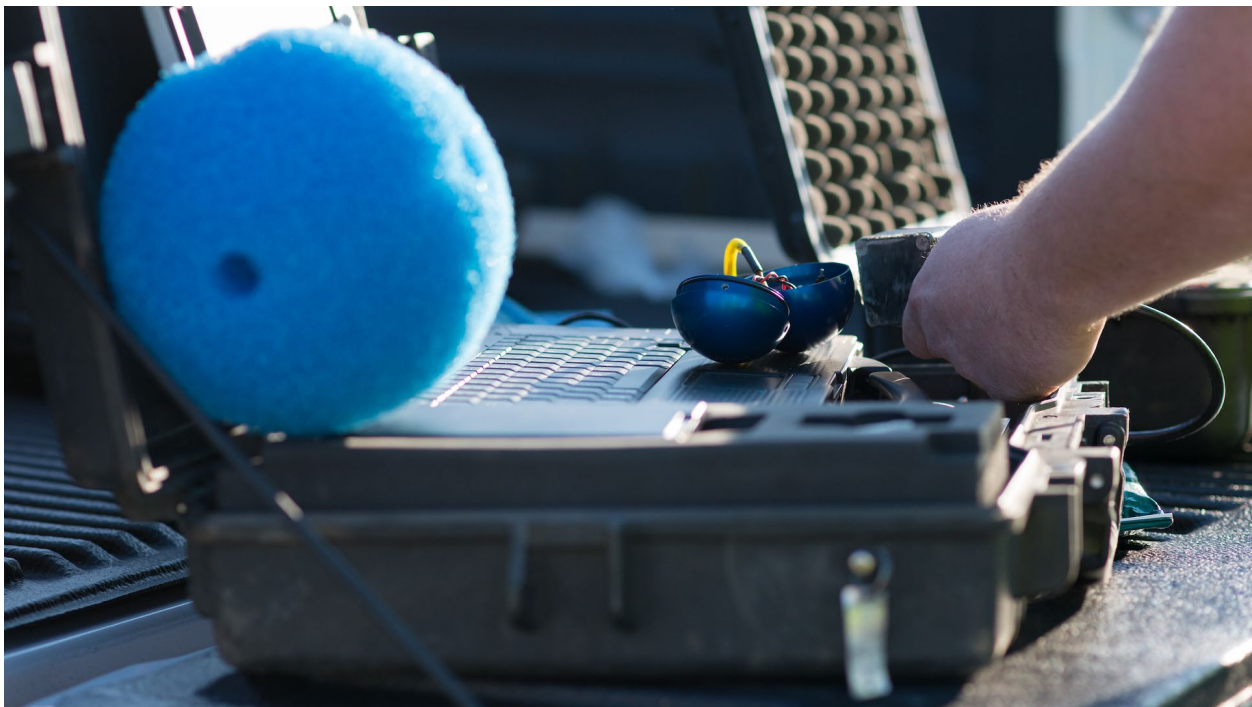
Figure C.1: Synchronizing a SmartBall Core with a SmartBall Tracking Device

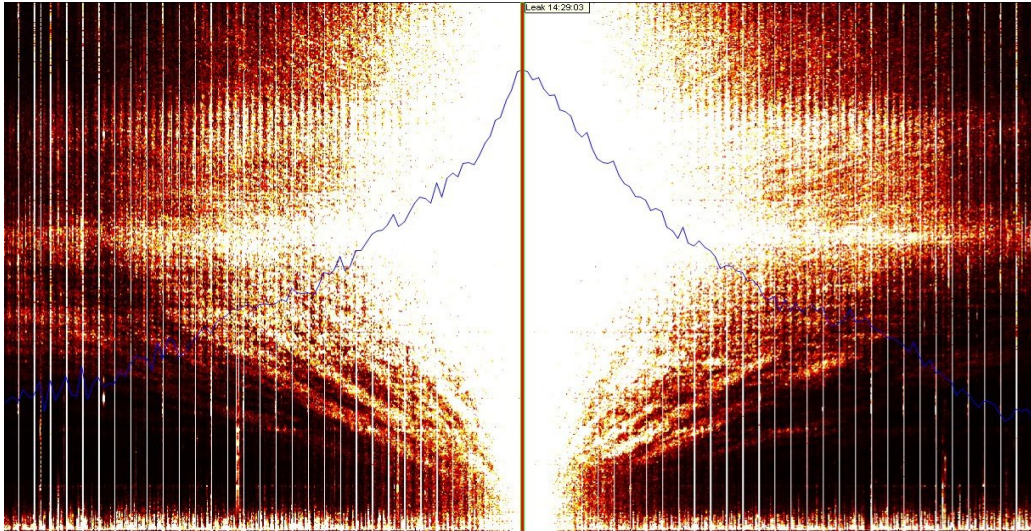
Figure C.2: Detected Leak, as shown in the SmartBall Analysis Software

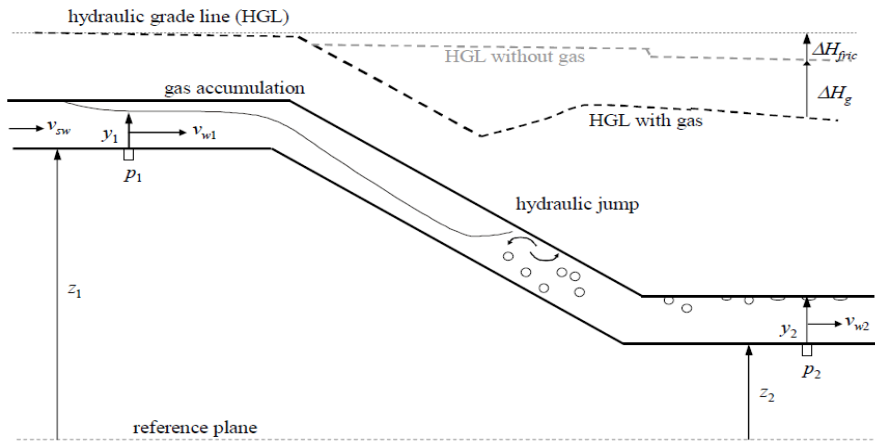
Figure C.5: Diagram of a Fully Developed Air or Gas Pocket³

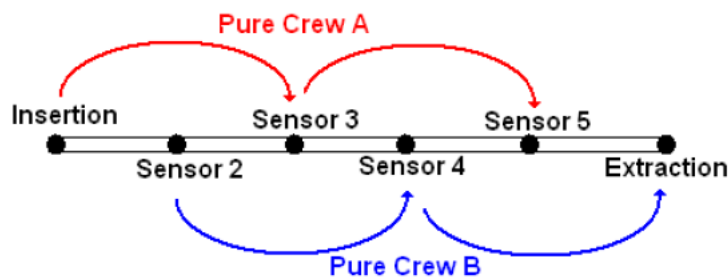
Typical leap frog during inspection

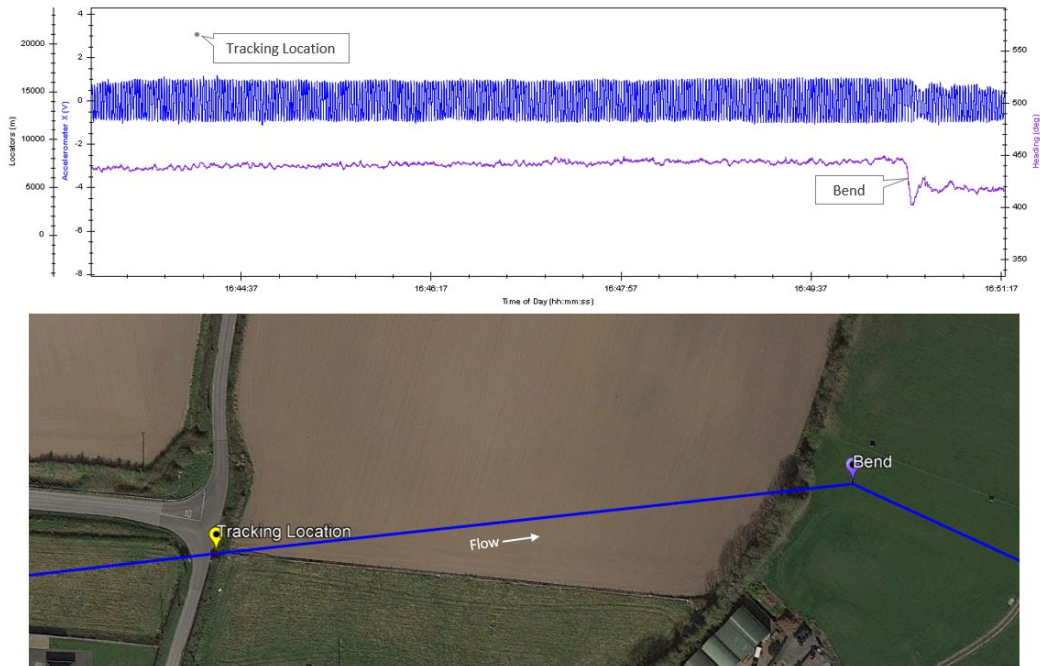
Figure C.8: Data Correlation - Example from Another Pipeline

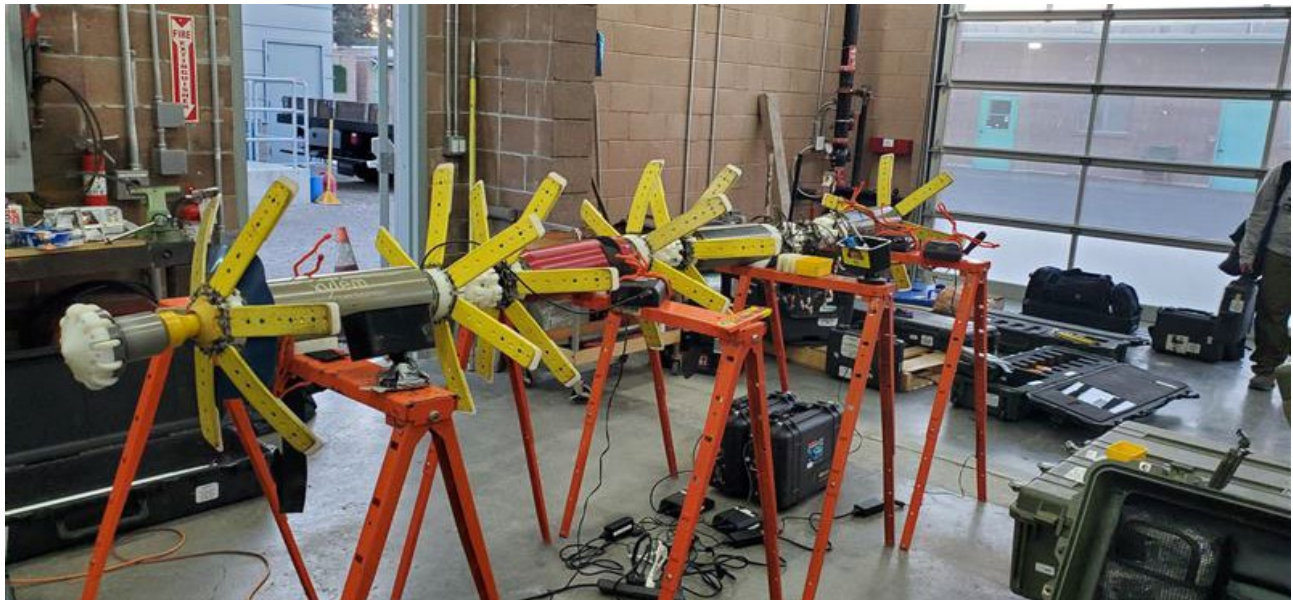
Figure 1.1: PipeDiver Inspection Platform

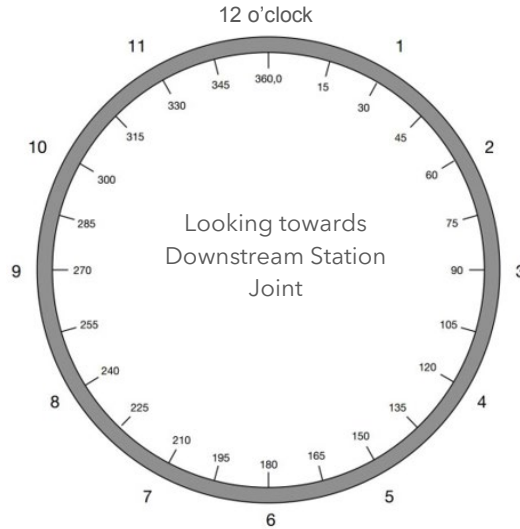
Figure 2.2: Radial Layout of Circumferential Degrees and Clock Position

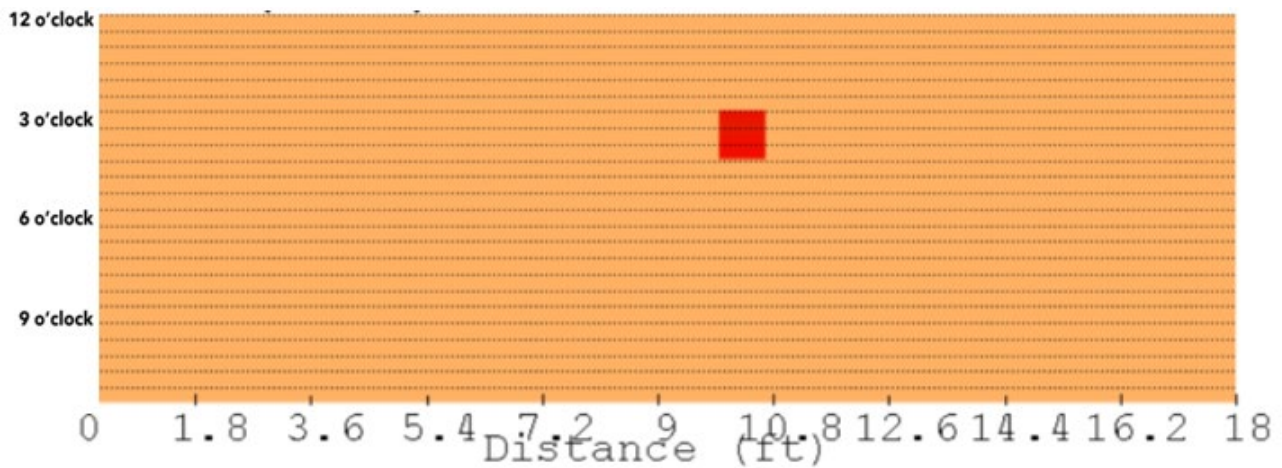
Figure 2.3: Pipes with Wall Loss Anomalies

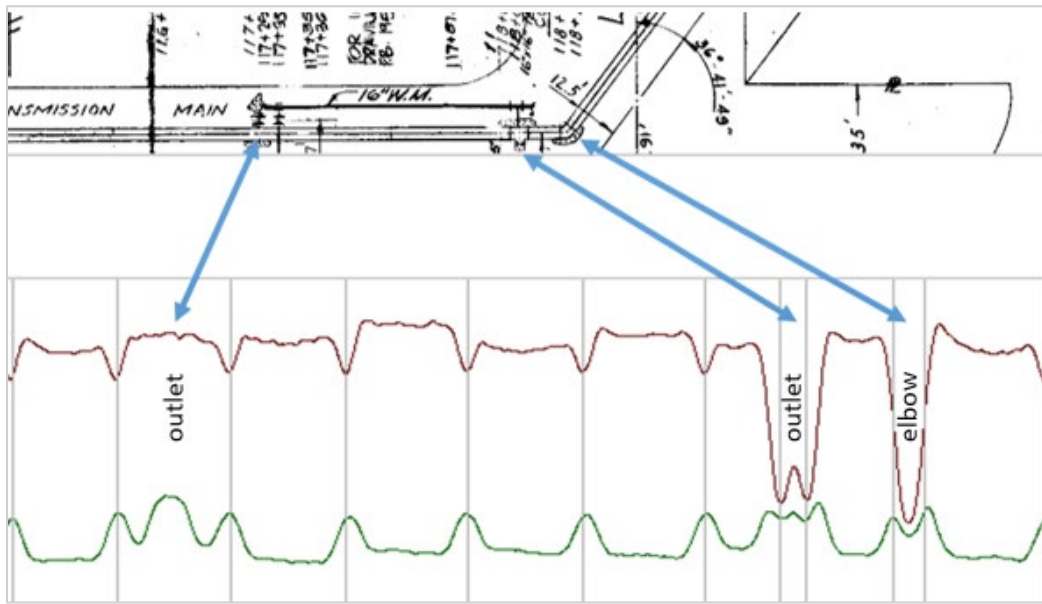
Figure 2.4: Data Correlation Example from Another Pipeline

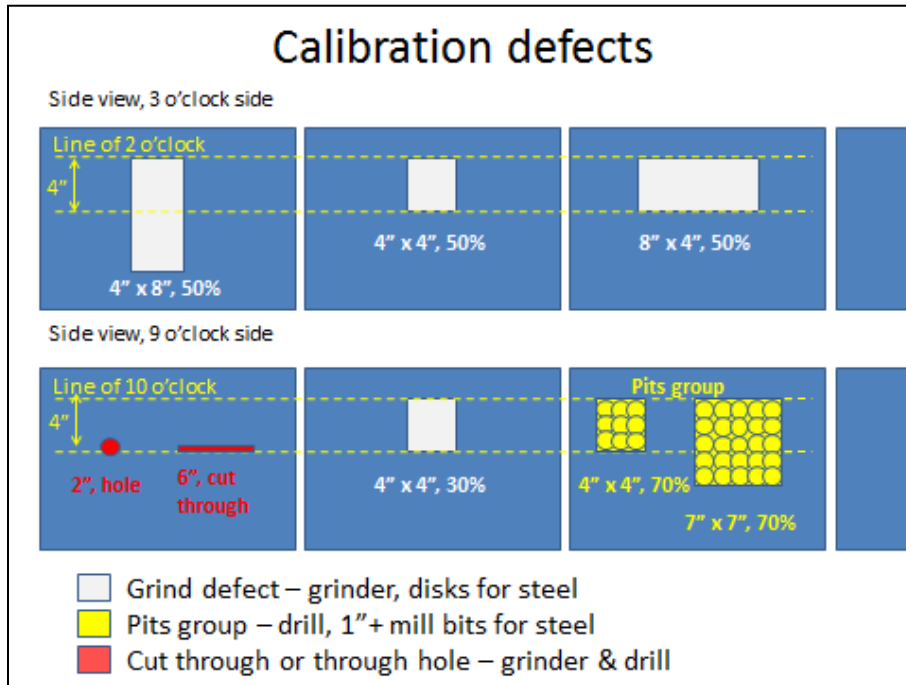
Figure A1.1: Sample of Defects Performed in a Pipe Wall Calibration

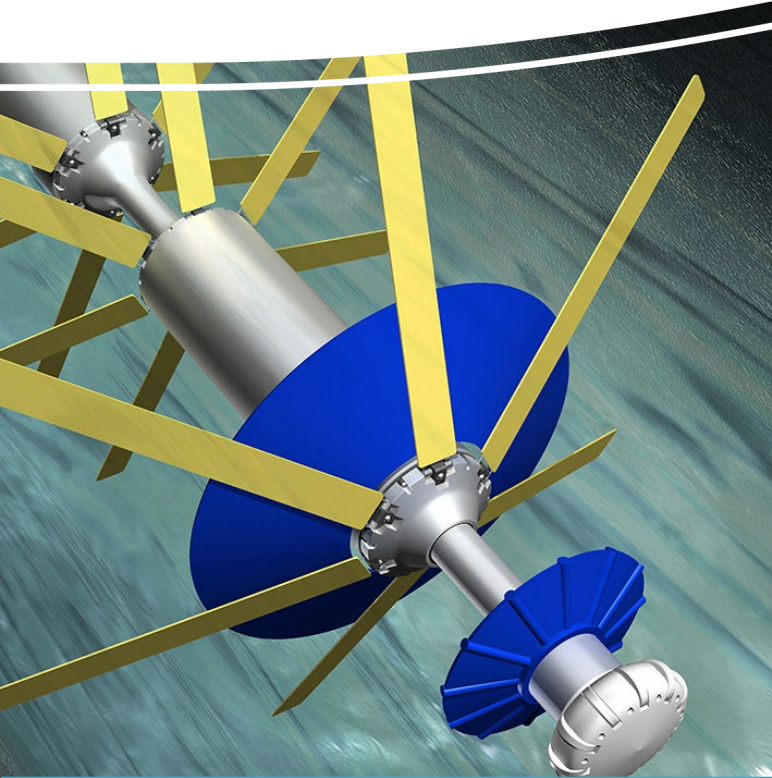
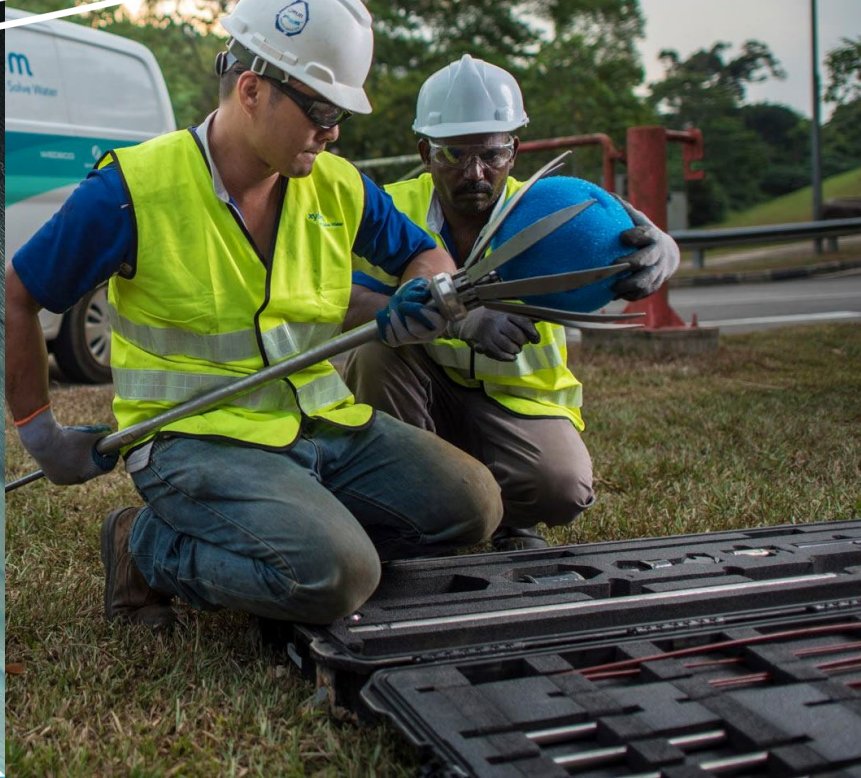
Condition Assessment Report

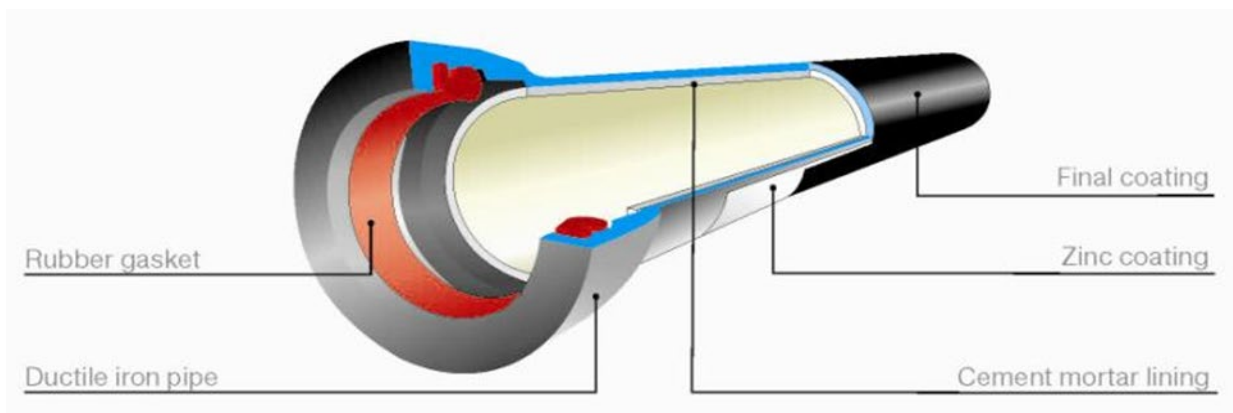
Figure 1.1: Cross Section of a DIP

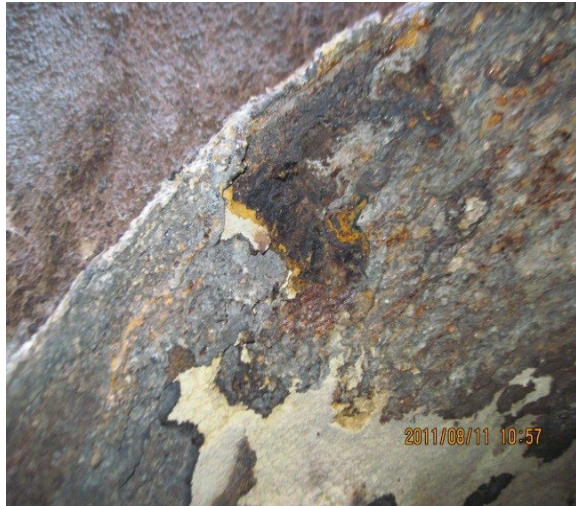
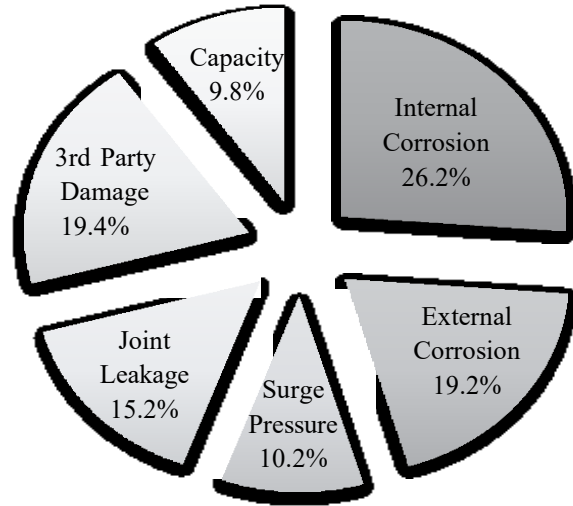
Figure 1.2: Internal Corrosion of DIP (left) and Dip Failure Modes (right)

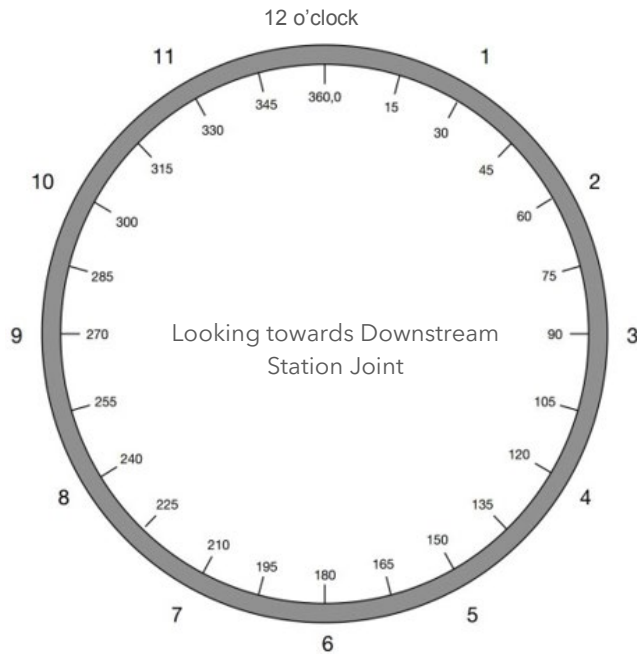
Figure 3.2: Radial Layout of Circumferential Degrees and Clock Position

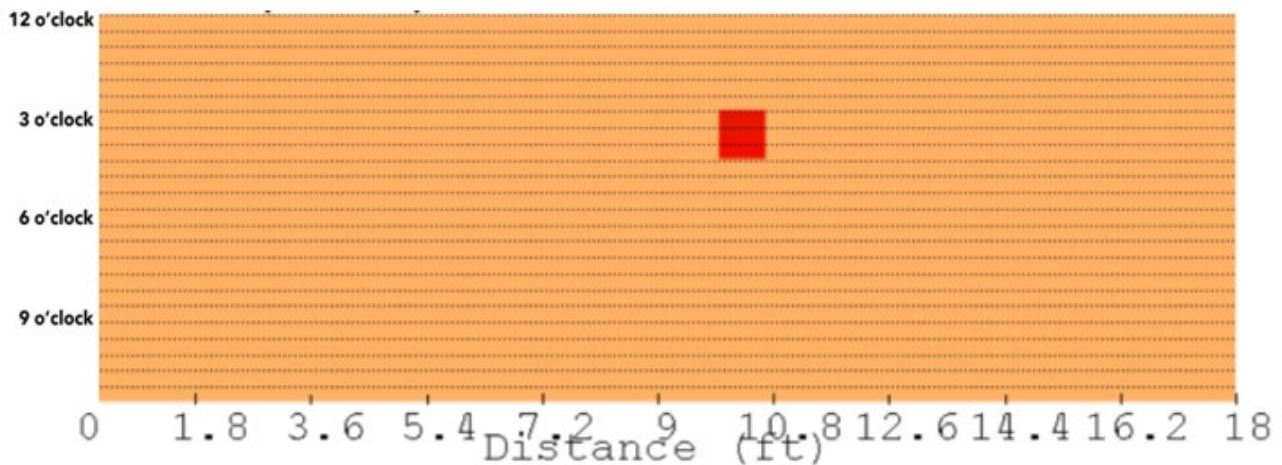
Figure 3.3: Pipes with Wall Loss Anomaly

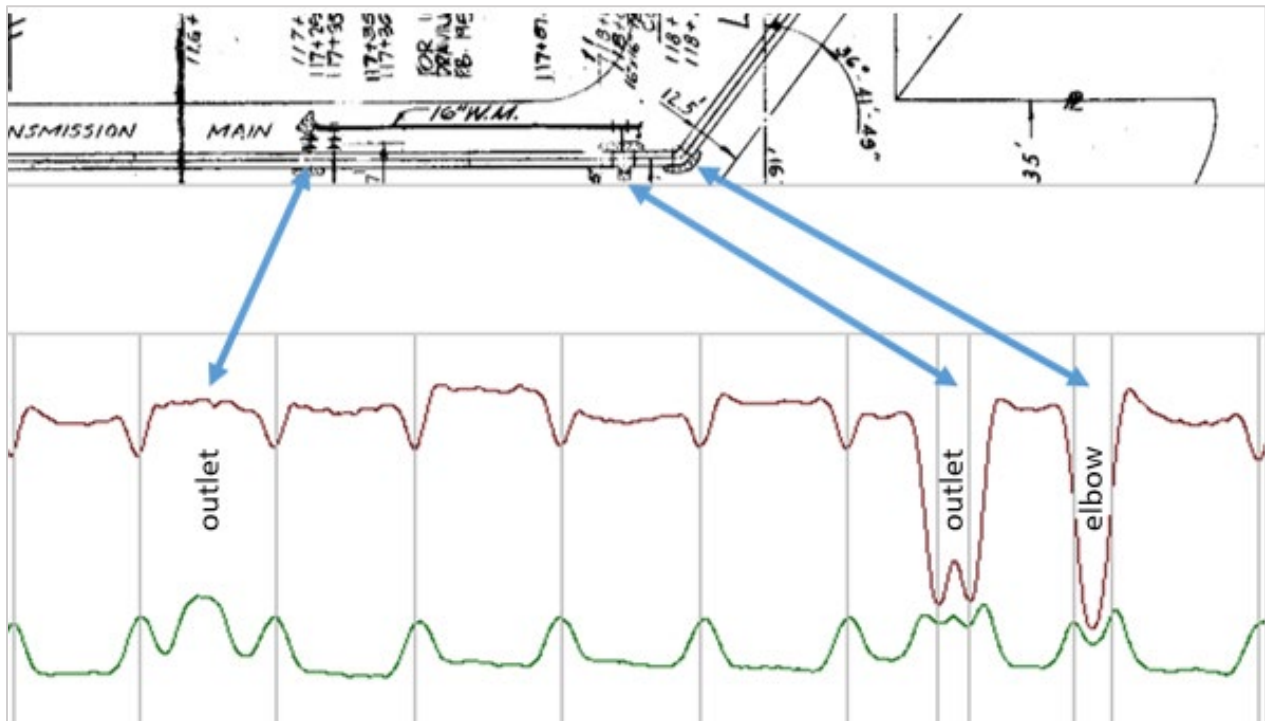
Figure 3.4: Data Correlation Example from Another Pipeline

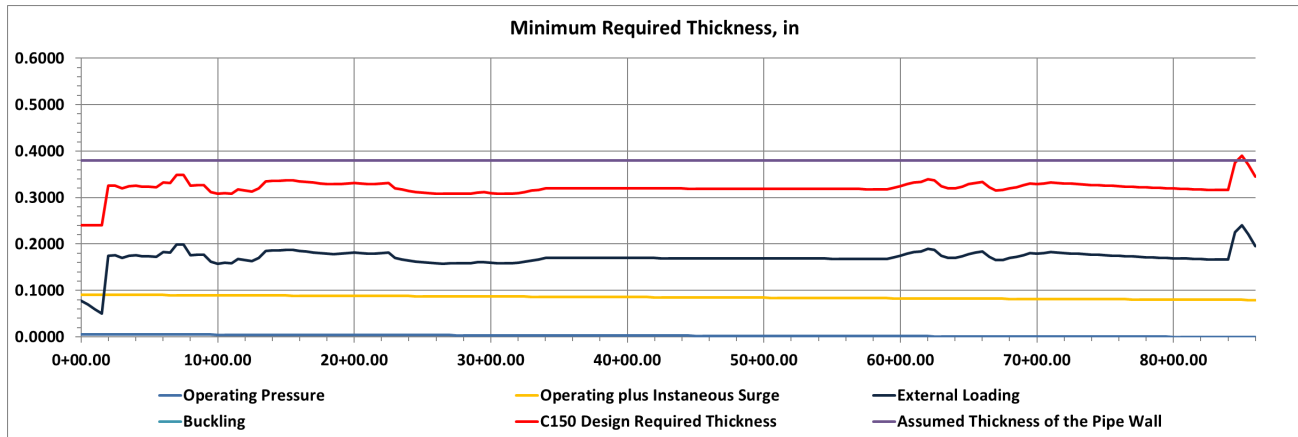
Figure 4.1: AWA C150 Structural Design Check

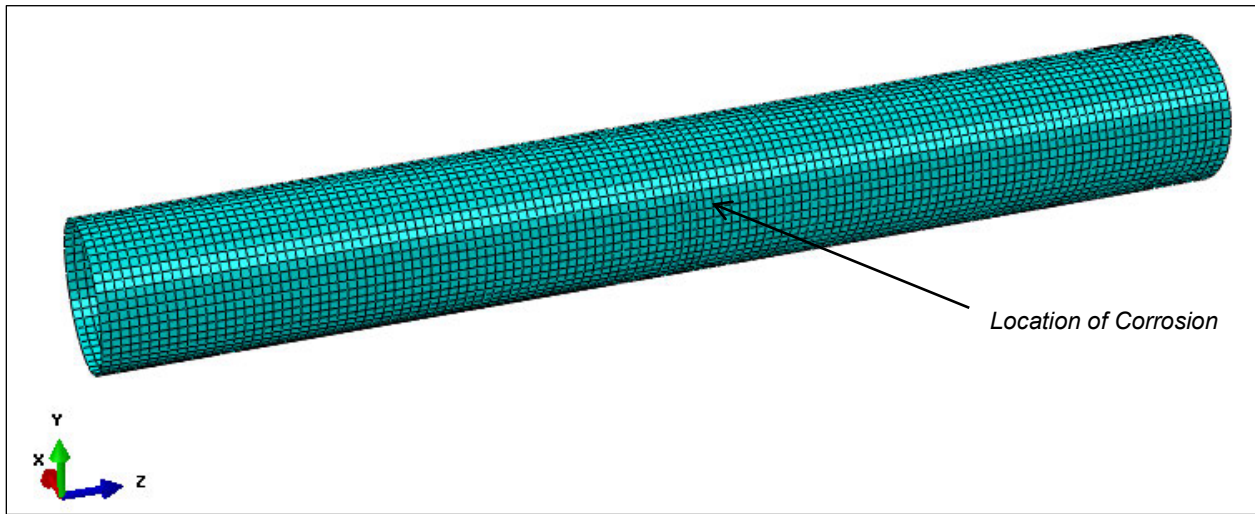
Figure 4.2: 3D Mesh of DIP Model

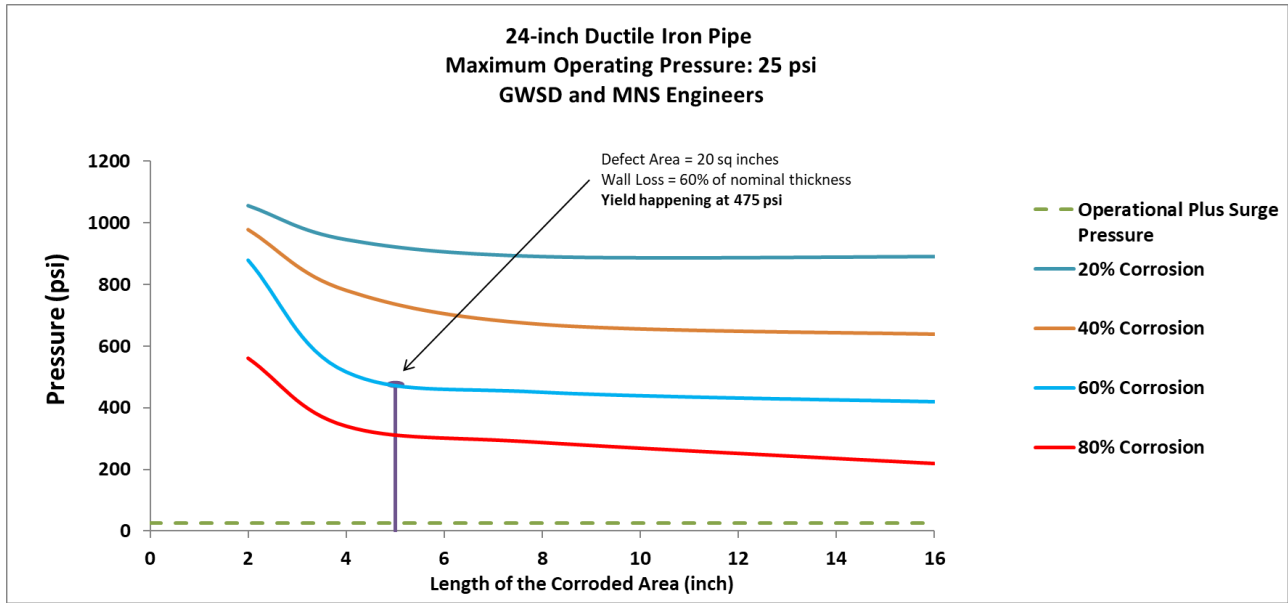
Figure 4.2: Finite Element Analysis Results for Pure Reference Number 10105

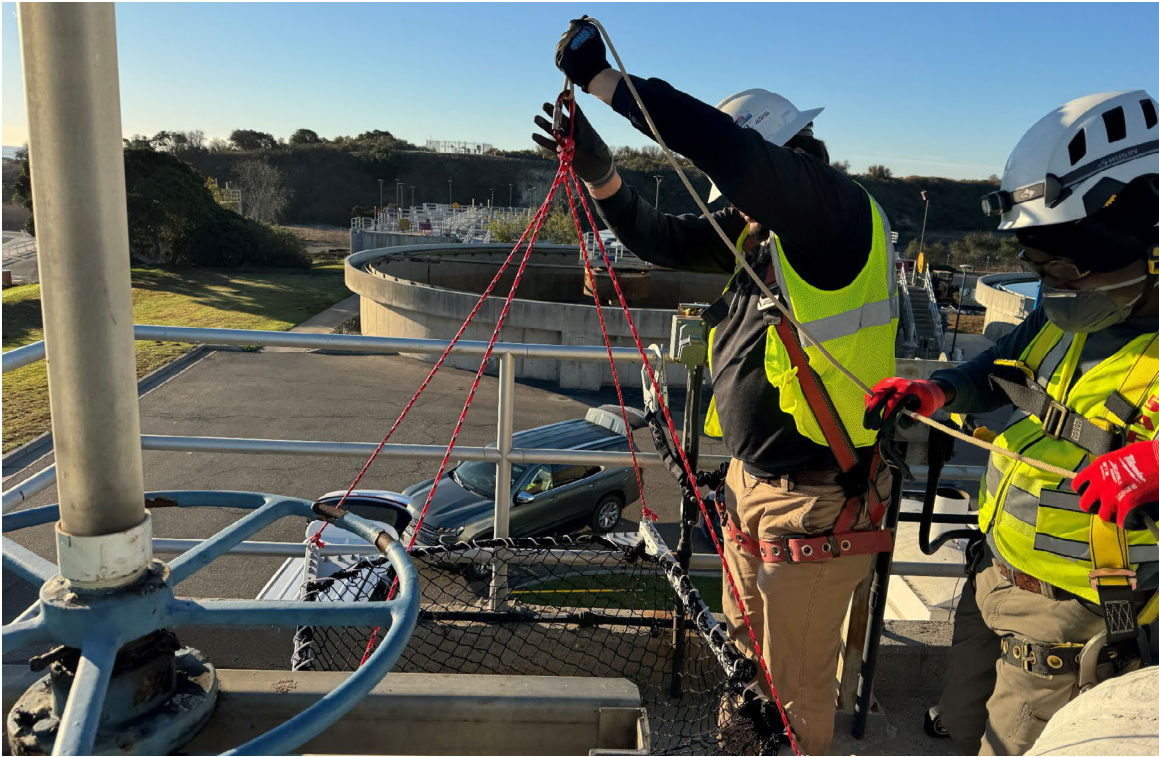
Figure 2.2: SmartBall Extraction Net Being Placed into Position

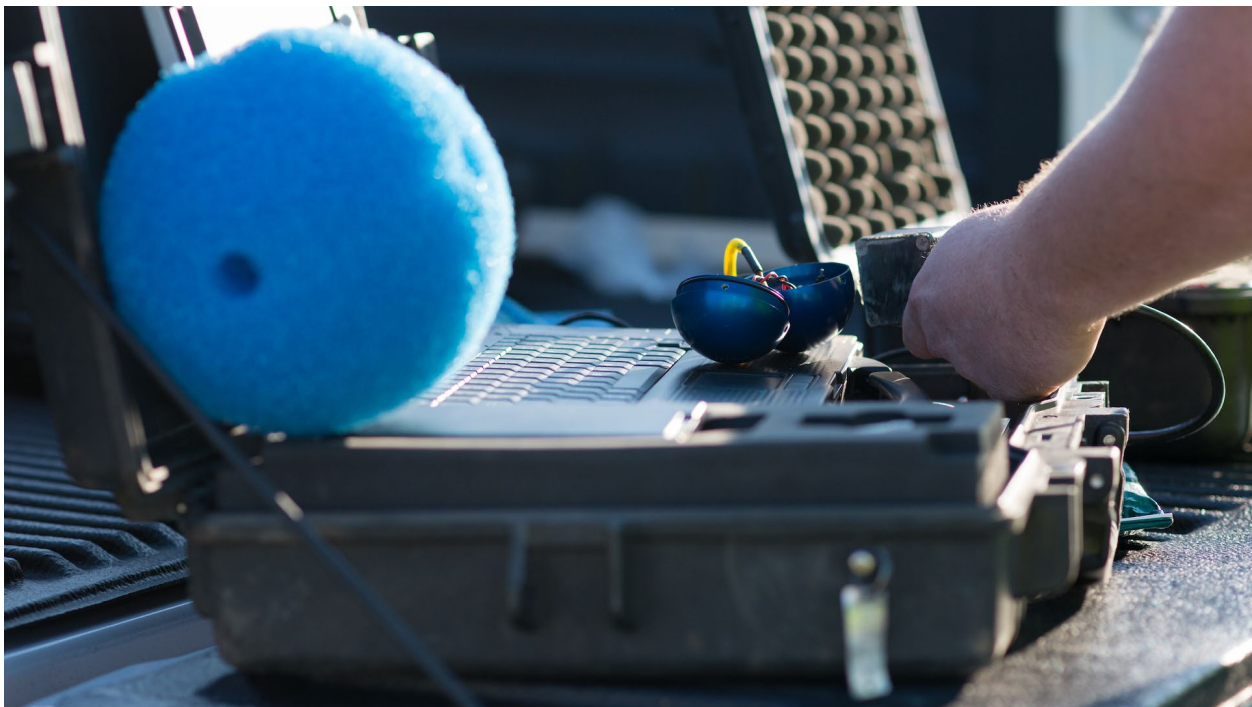
Figure C.1: Synchronizing a SmartBall Core with a SmartBall Tracking Device

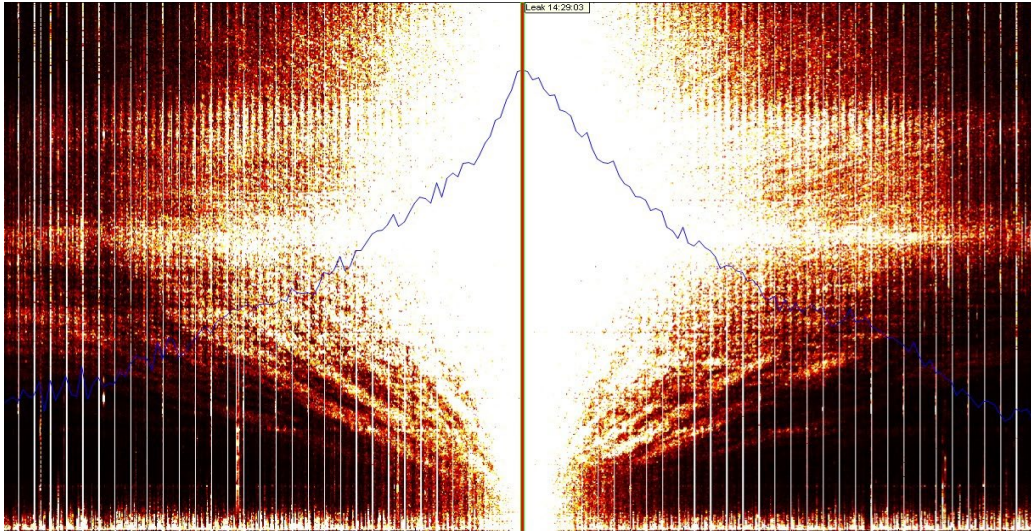
Figure C.2: Detected Leak, as shown in the SmartBall Analysis Software
