GOLETA WEST SANITARY DISTRICT

FORCE MAIN INSPECTION SUMMARY AND RECOMMENDATIONS

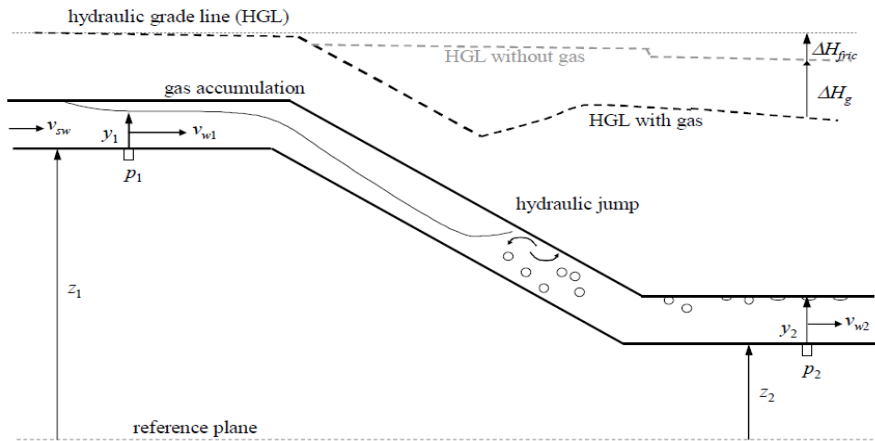
Figure C.5: Diagram of a Fully Developed Air or Gas Pocket³

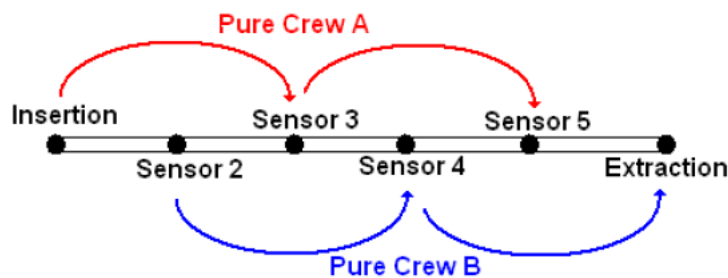
Typical leap frog during inspection

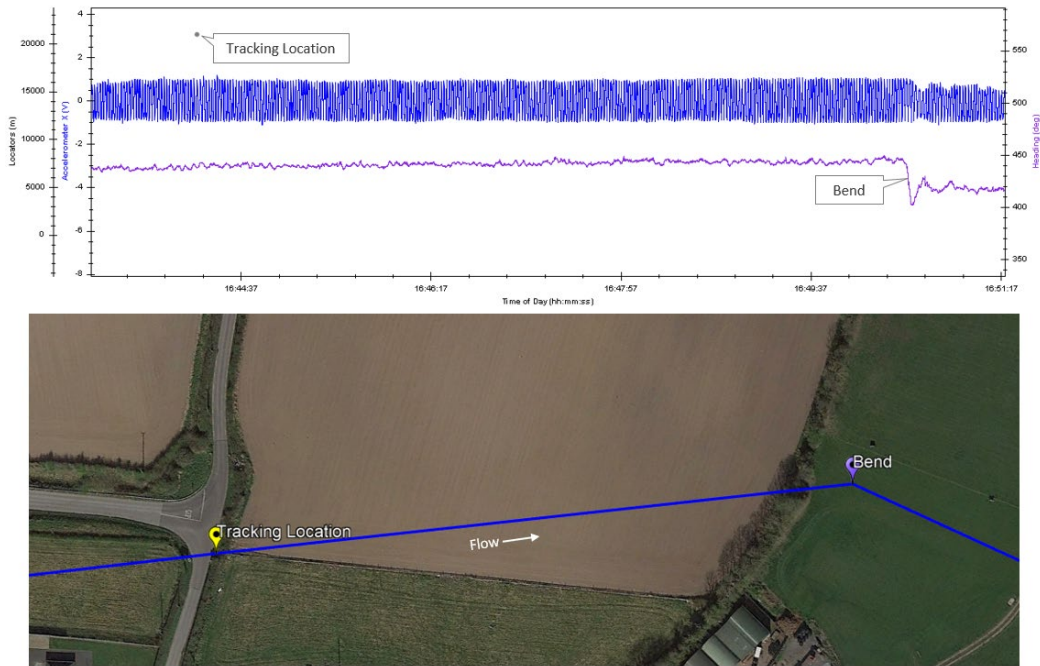
Figure C.8: Data Correlation - Example from Another Pipeline

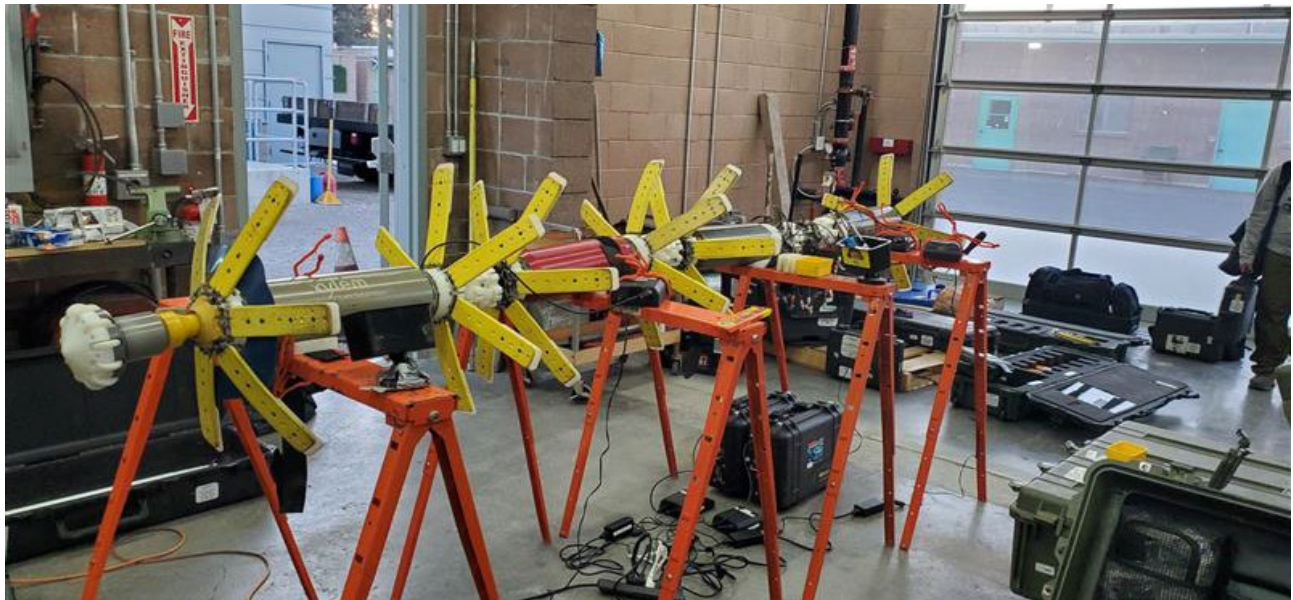
Figure 1.1: PipeDiver Inspection Platform

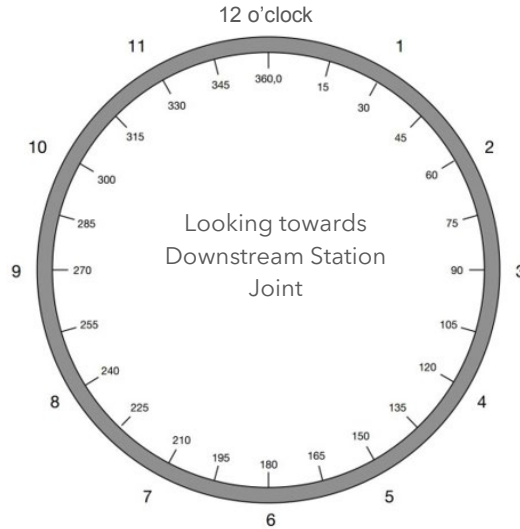
Figure 2.2: Radial Layout of Circumferential Degrees and Clock Position

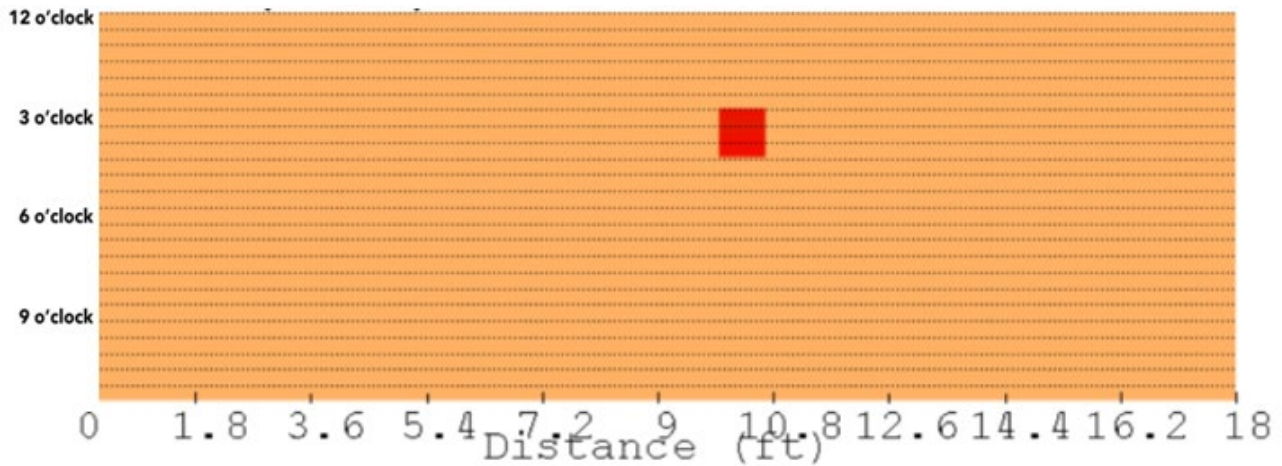
Figure 2.3: Pipes with Wall Loss Anomalies

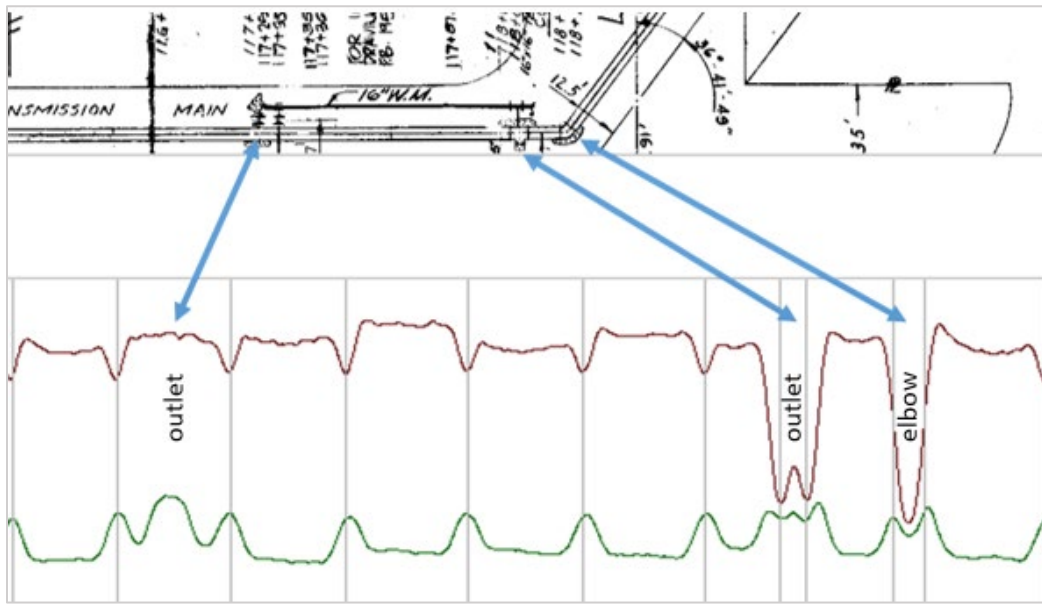
Figure 2.4: Data Correlation Example from Another Pipeline

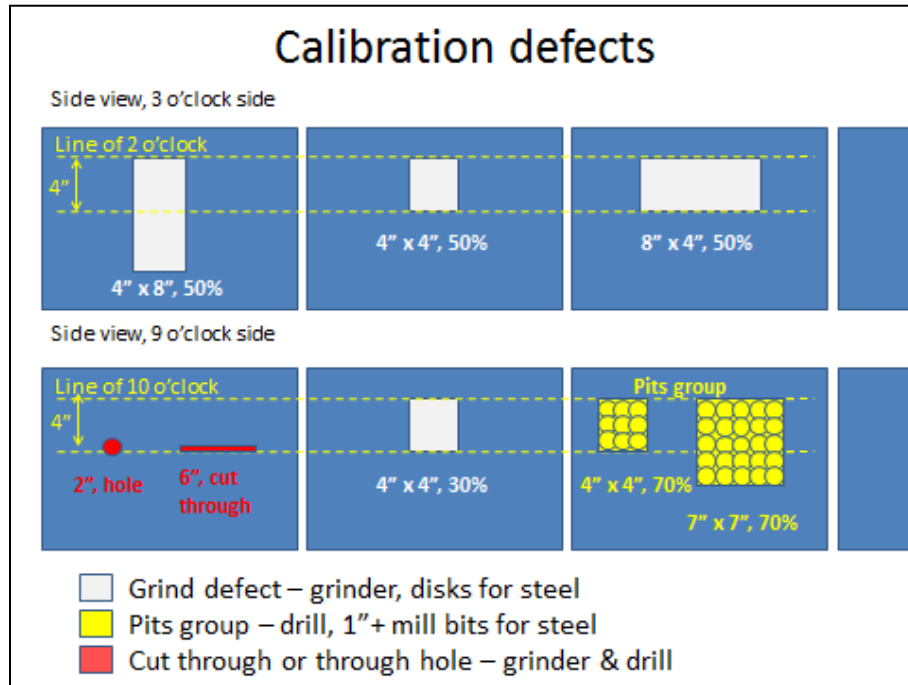
Figure A1.1: Sample of Defects Performed in a Pipe Wall Calibration

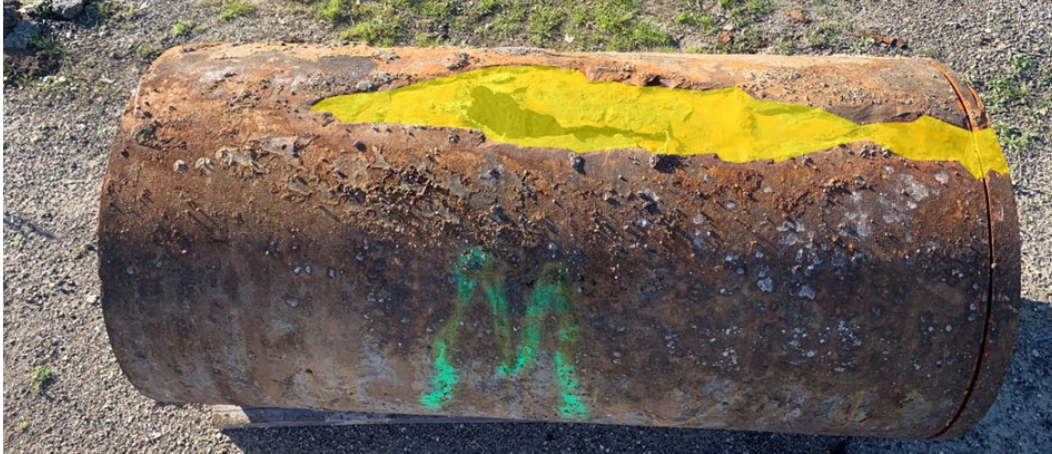
Figure 1: General corrosion found in 2024 failure (pipe has been rotated 180-deg)

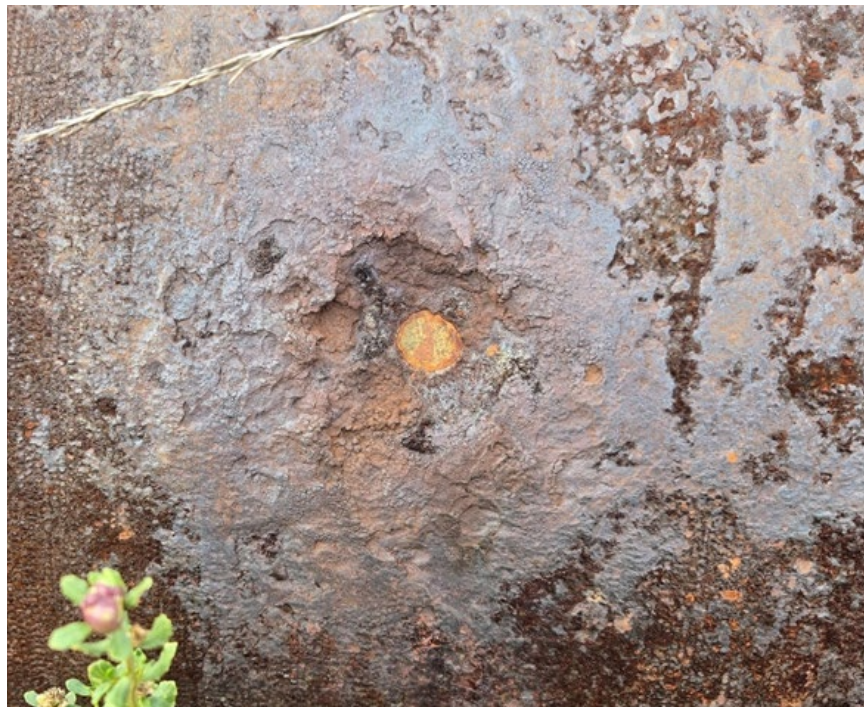
Figure 2: Corrosion through-hole at Pure's "Anomaly Area"

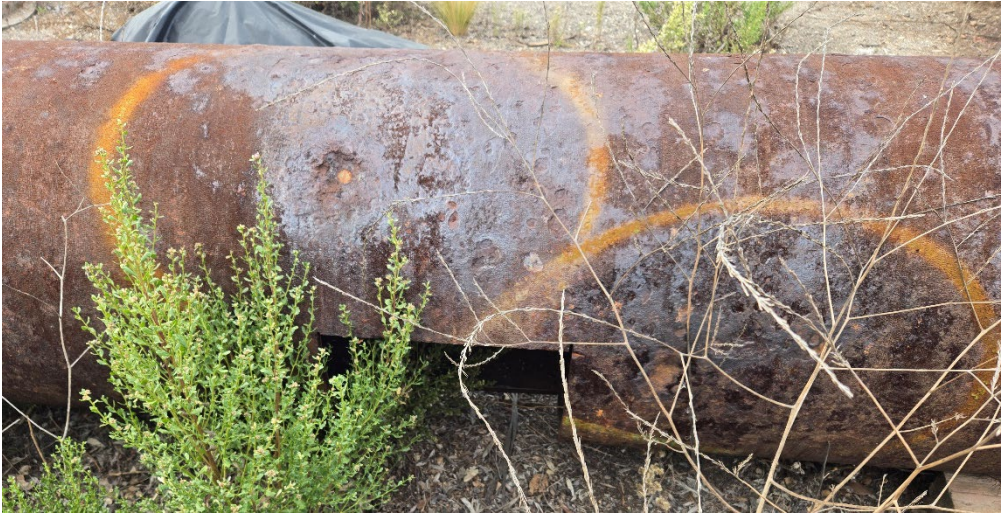
Figure 3: Corroded pipe in vicinity of Pure's "Anomaly Area"

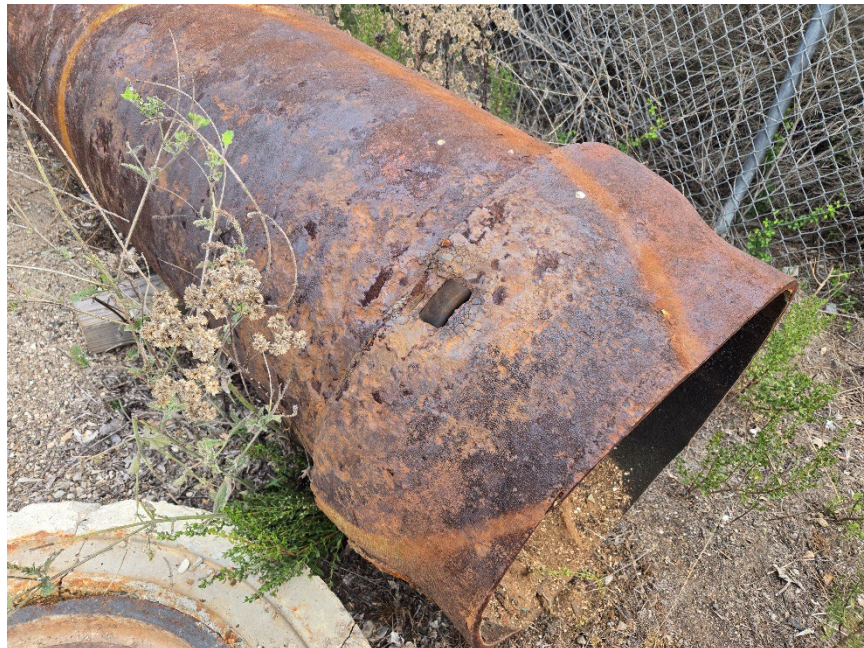
Figure 4: Through-hole at pipe joint

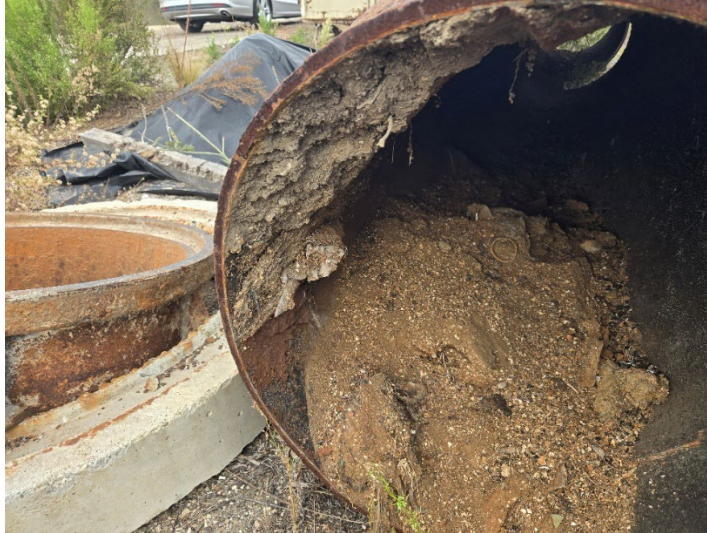
Figure 5: Solids accumulation in pipe invert (now seen in 10 o'clock position)

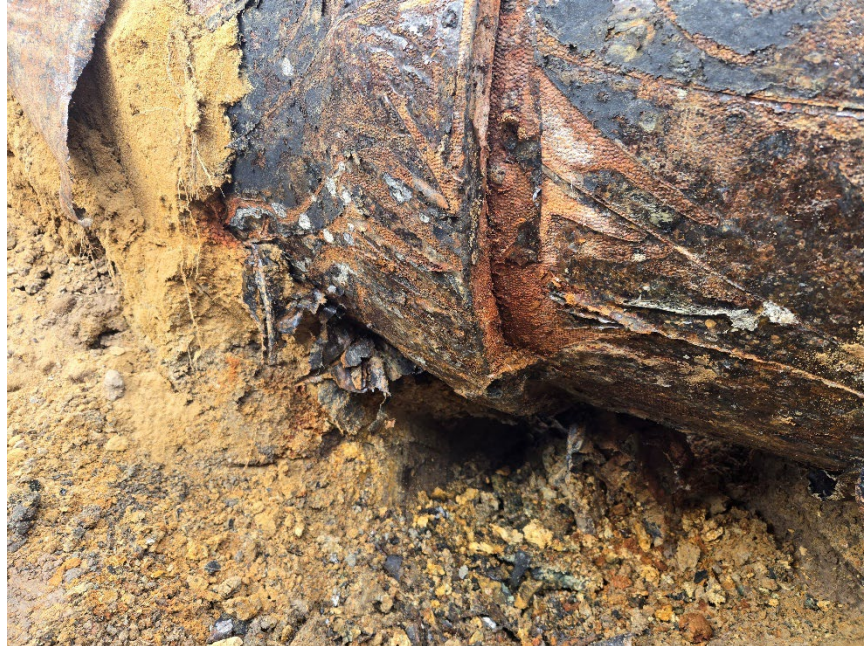
Figure 6: Corrosion near pipe bell at STA 69+50

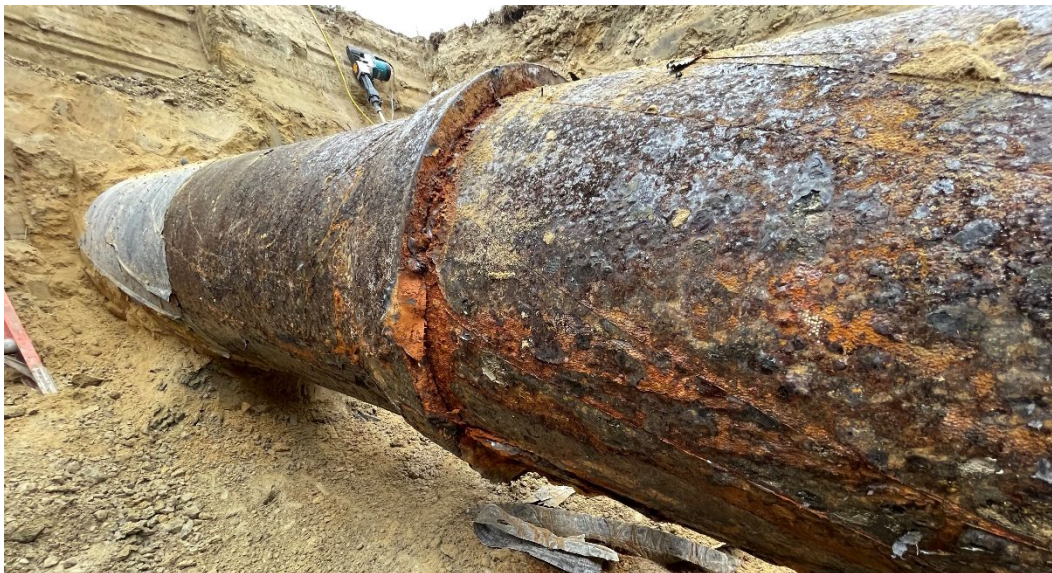
Figure 7: Corroded bell and spigot at excavation east of Moffet Place

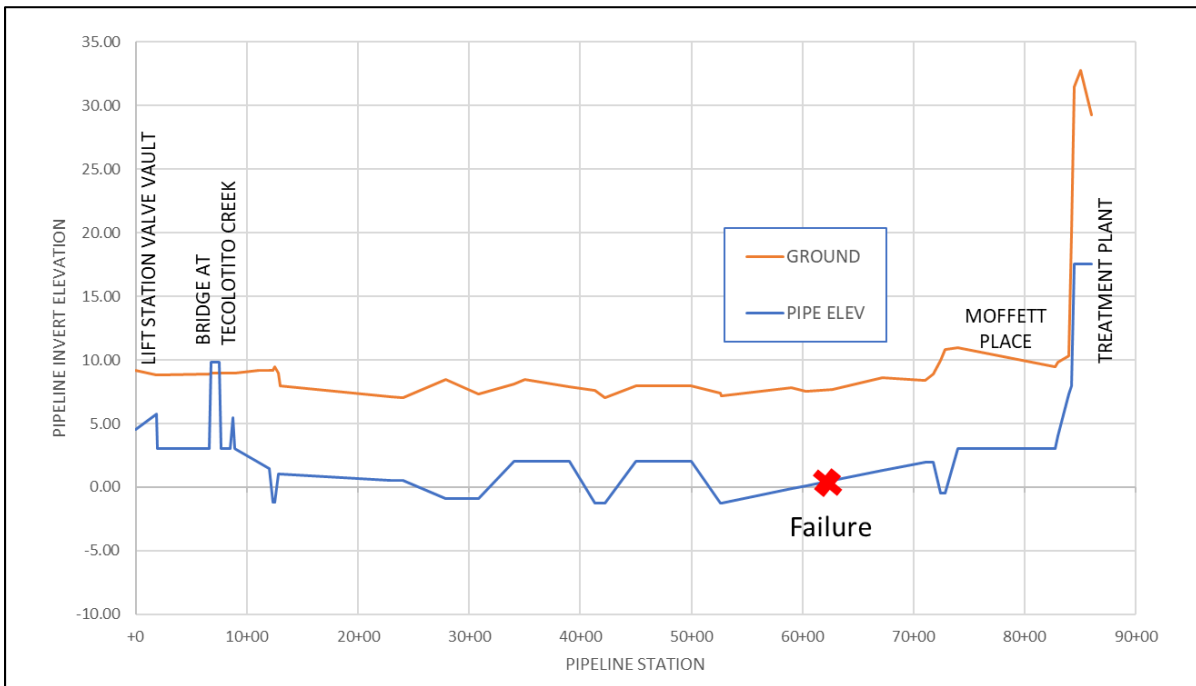
Figure 8: Force Main Profile – based on record drawings

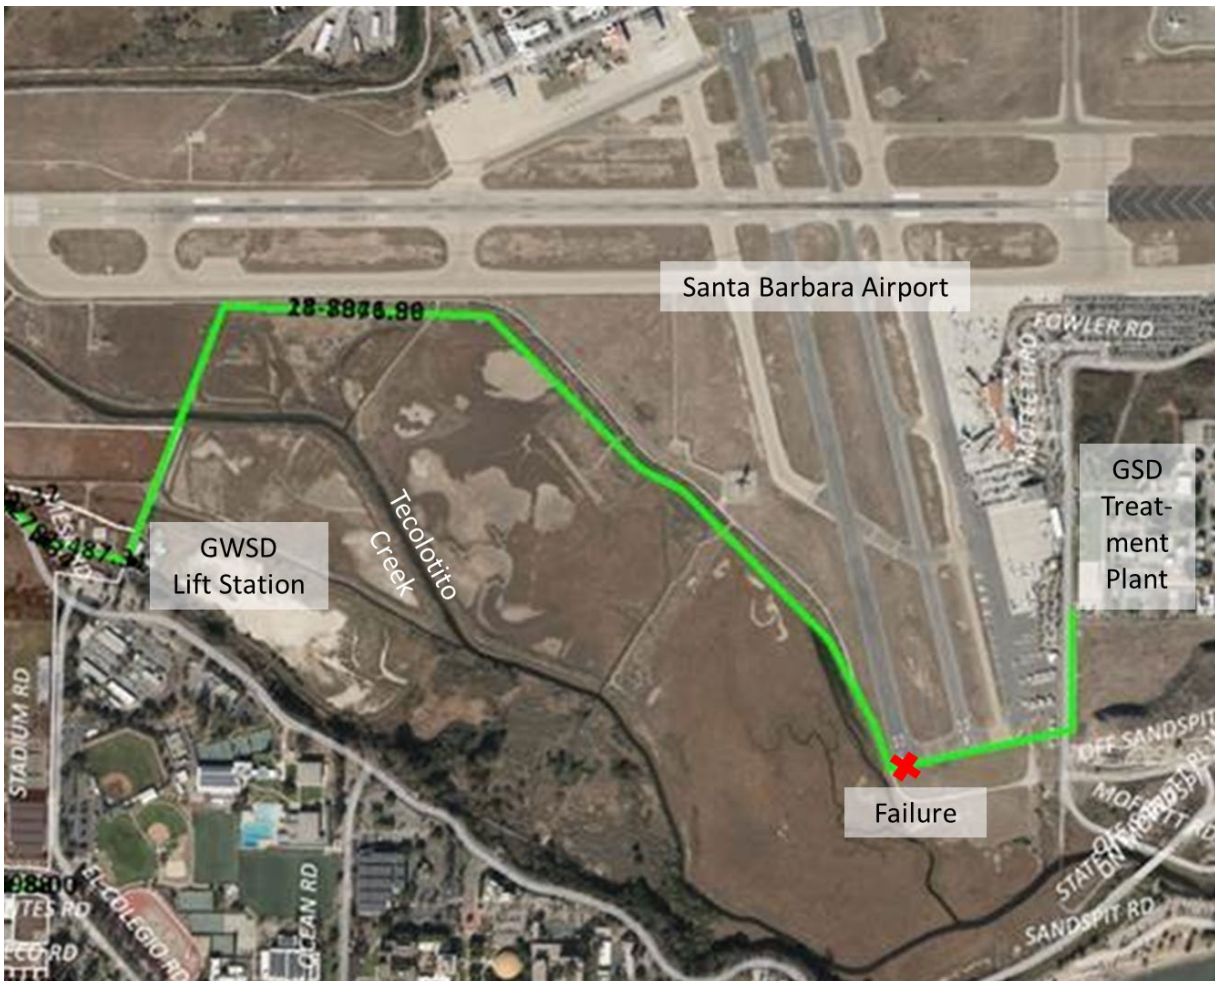
Figure 1: Force Main Alignment

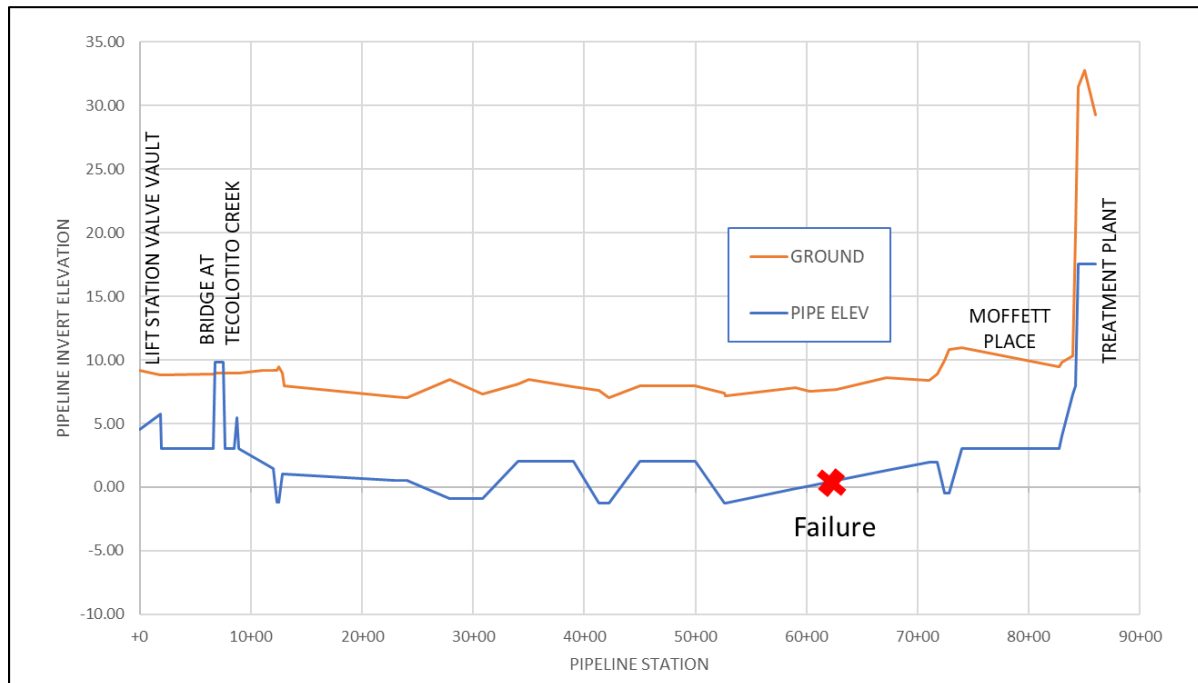
Figure 2: Force Main Profile – based on record drawings

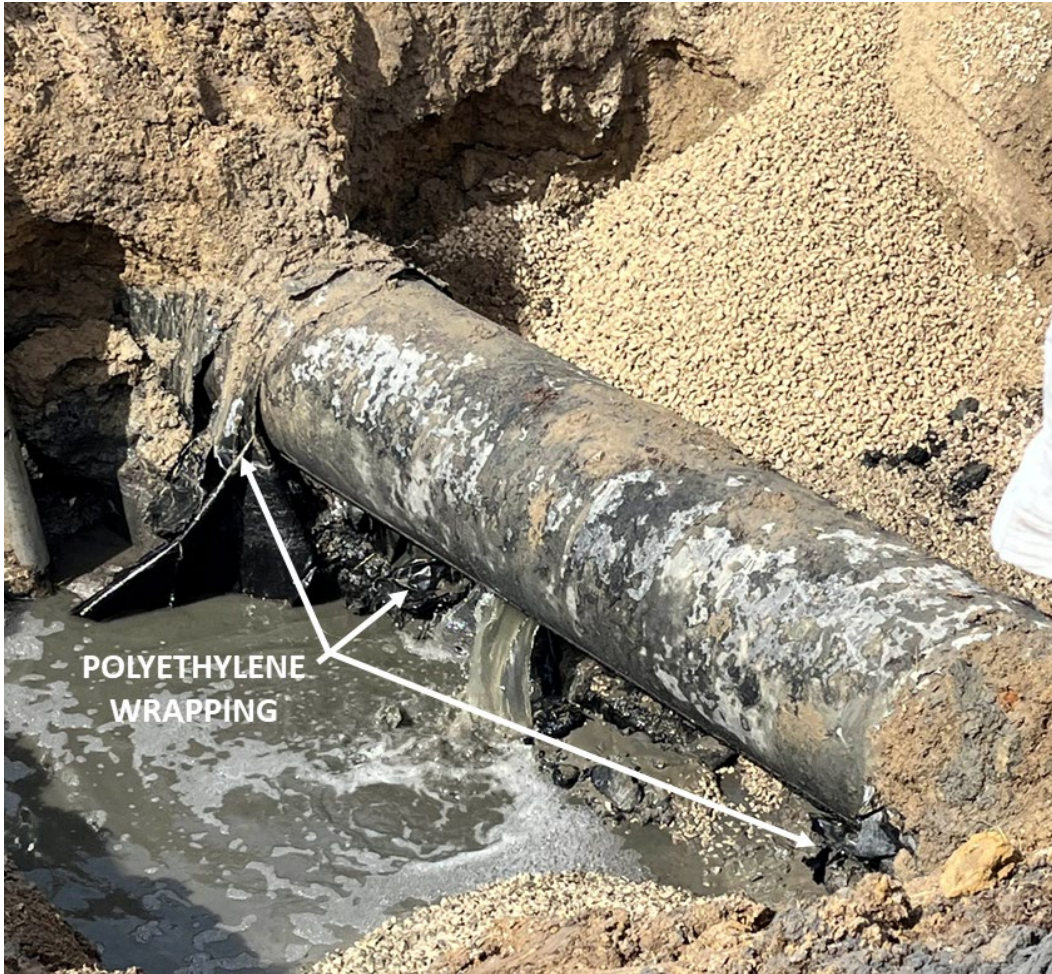
Figure 3: Photo of the 24-inch force main failure showing remnants of polyethylene wrapping

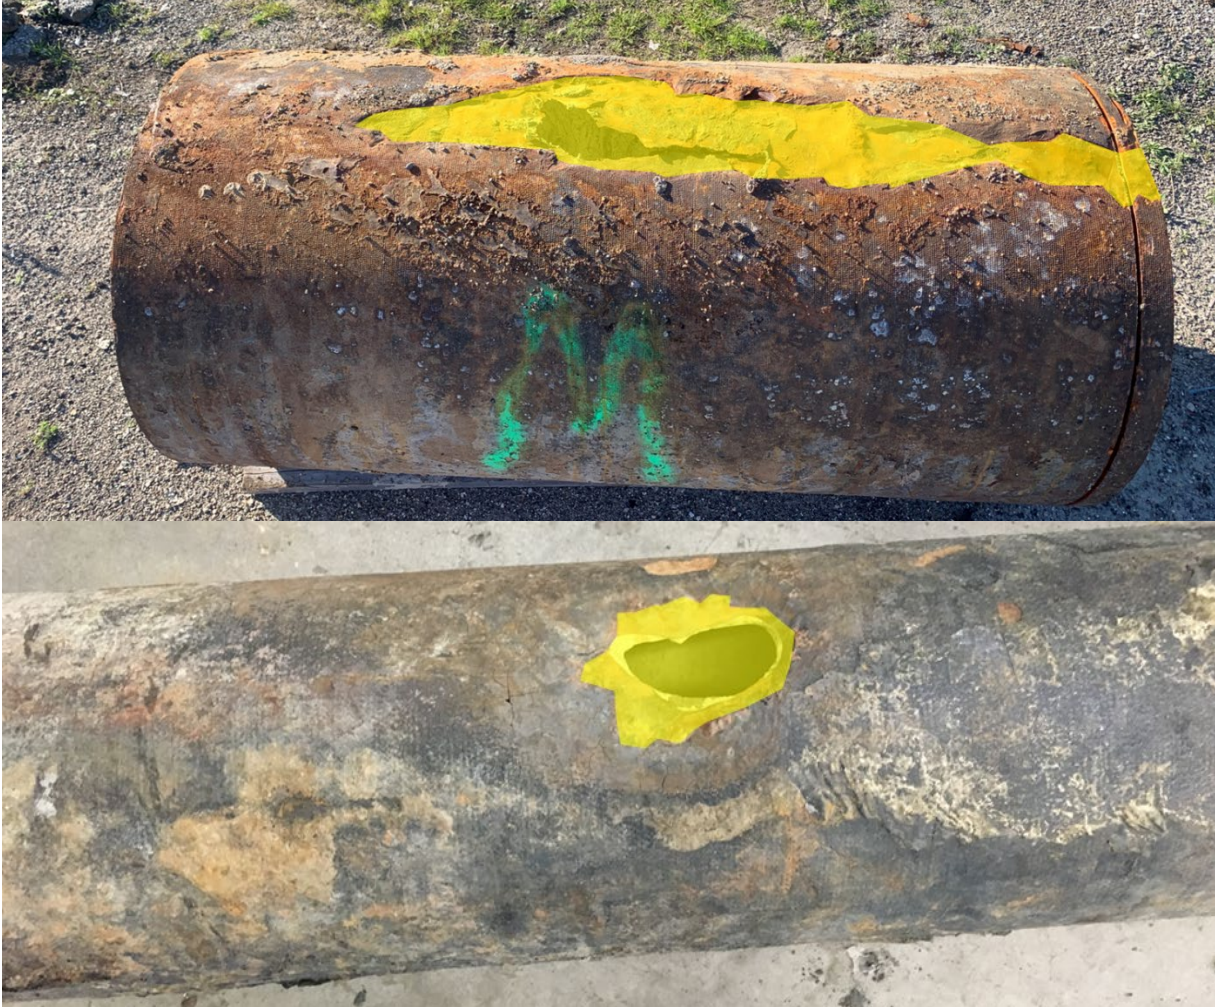
Figure 4: Highlighted areas show:

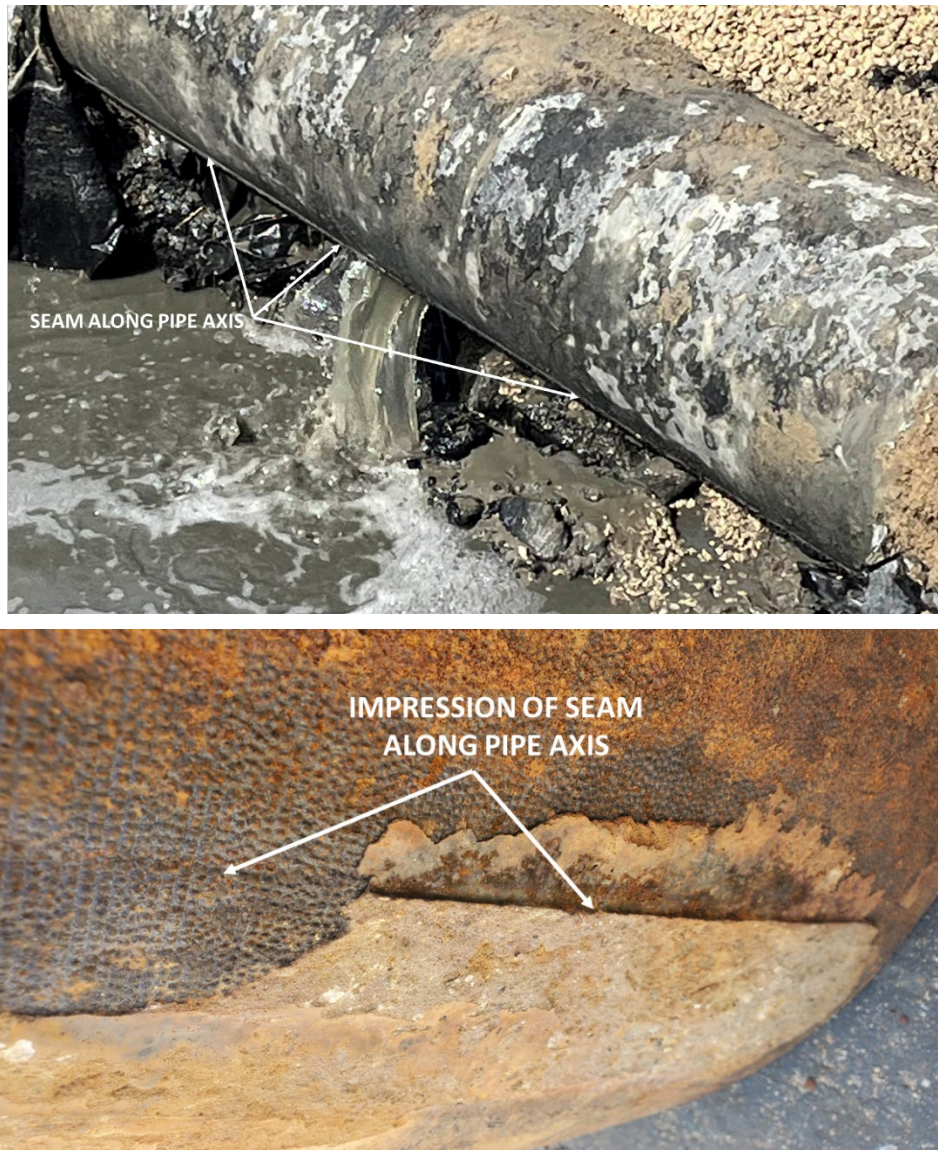
Figure 5: Photos suggesting a seam along the pipe axis, near the failure

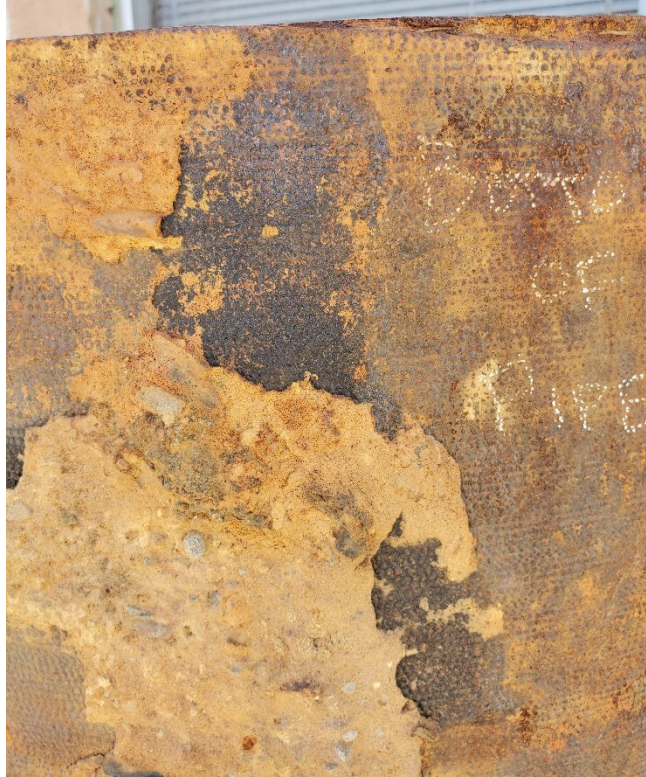
Figure 6: Encrusted scale with embedded aggregate

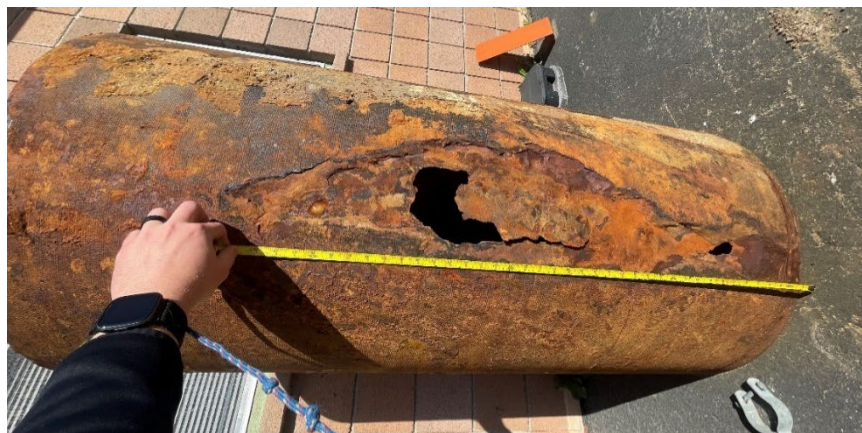
Figure 7: Failure section of the pipe

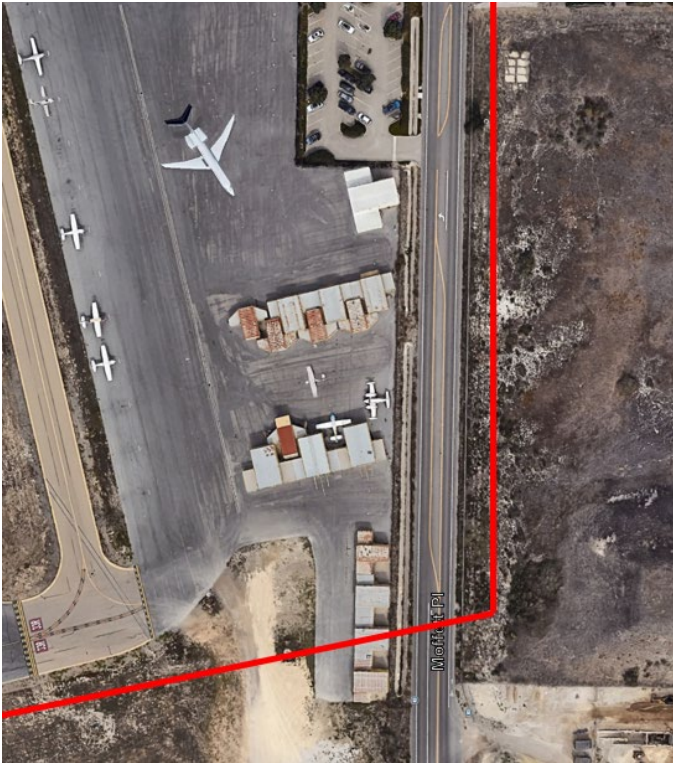
GWSD Forcemain Soil Corrosivity Study

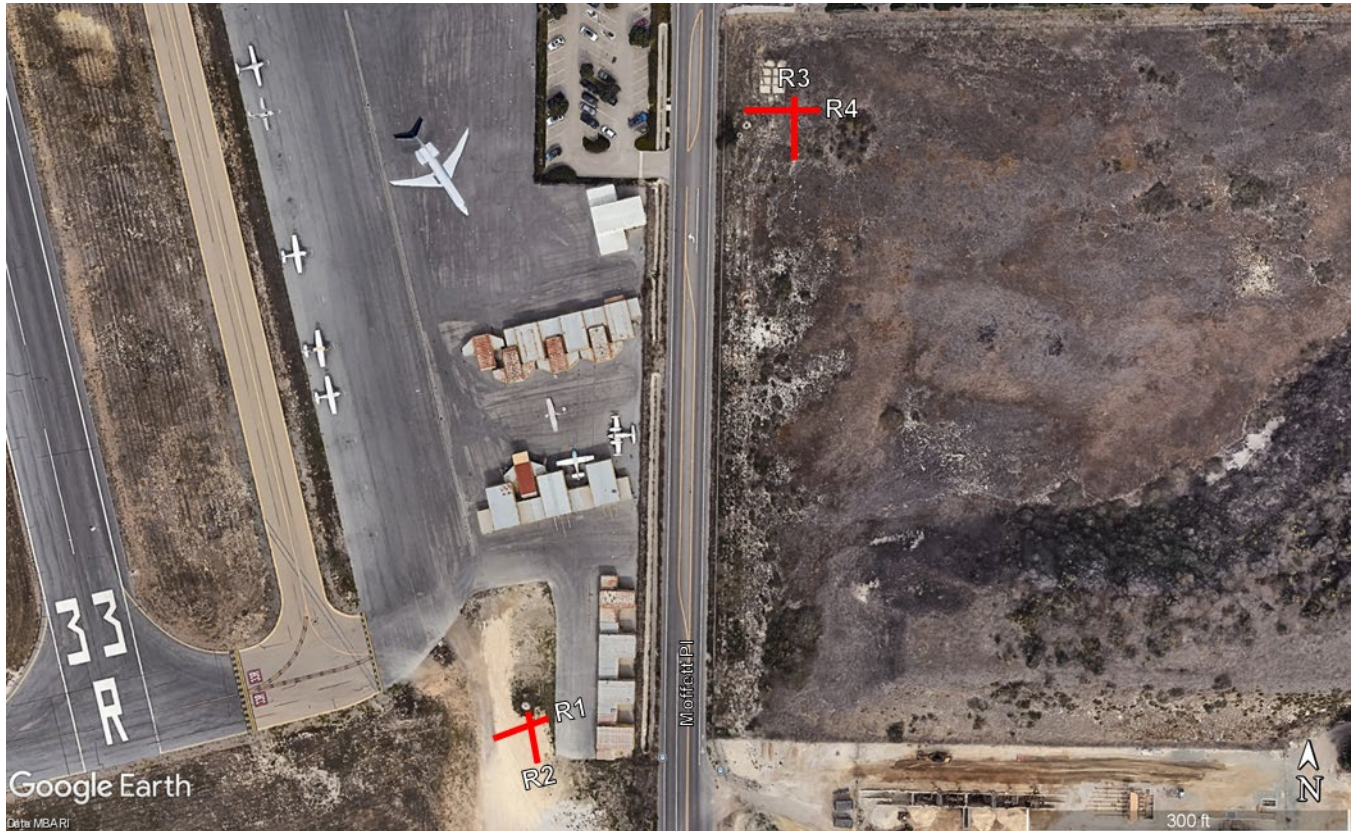
Figure 1. Wenner Four-Pin resistivity test locations

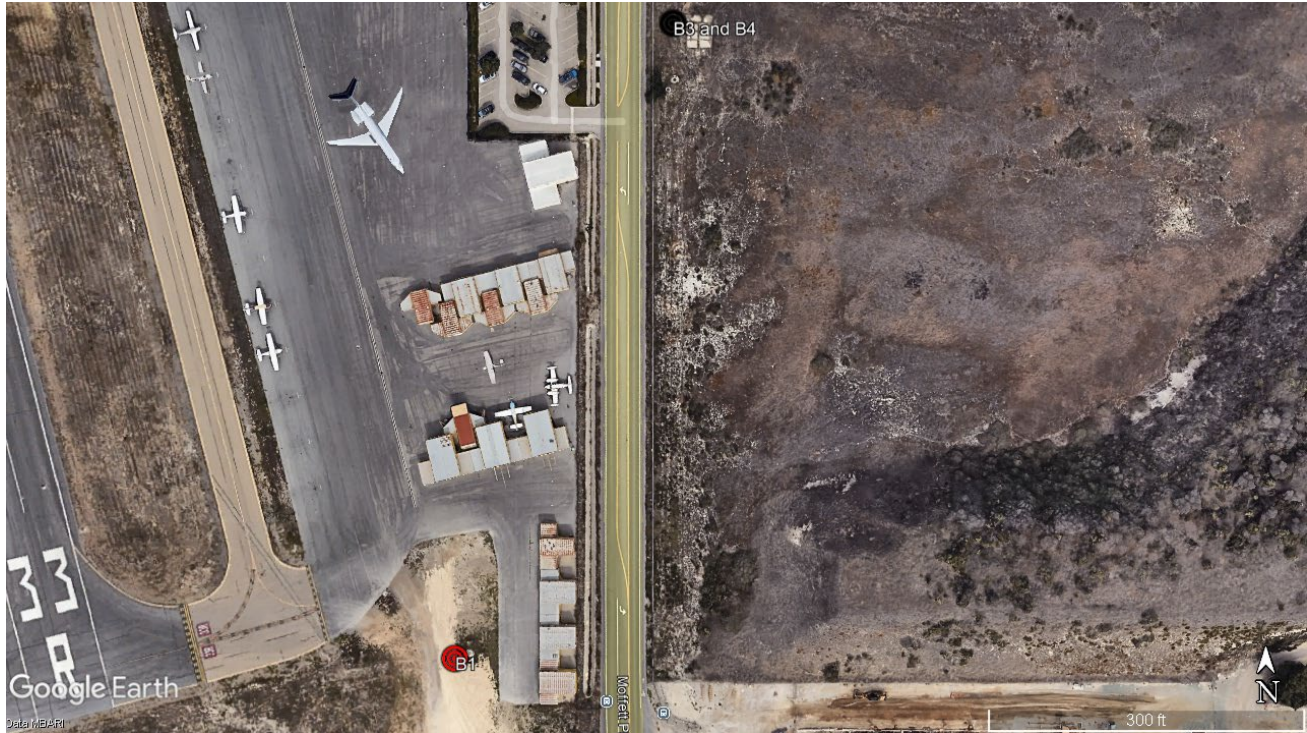
Figure 2. Approximate area of soil samples

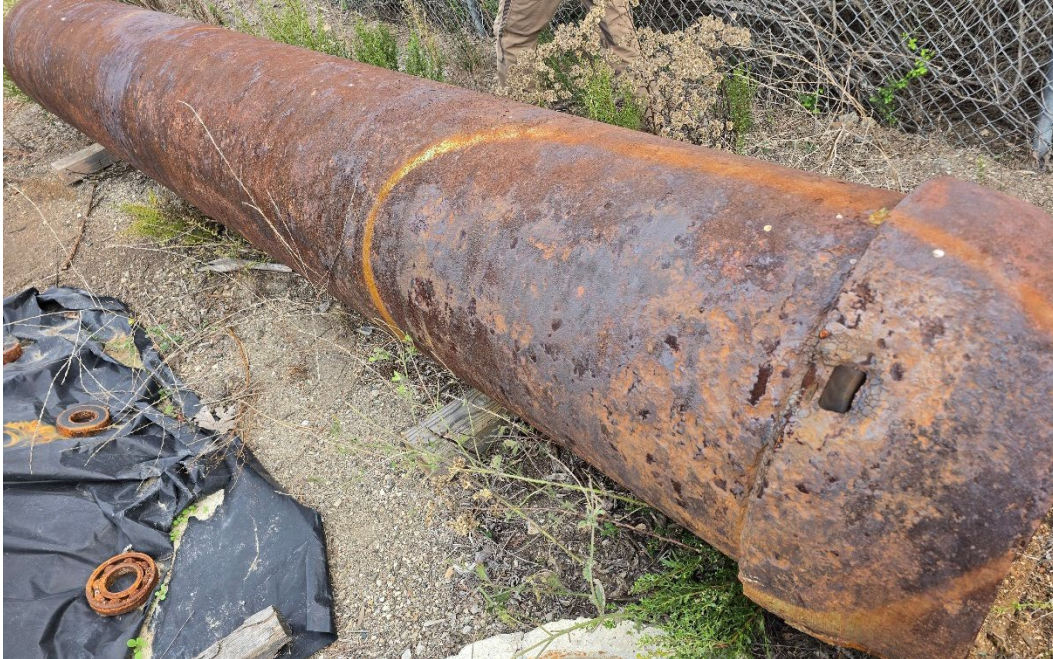
Figure 4. Overview of the replaced portion of 24-inch ductile iron pipe from near STA 78+00

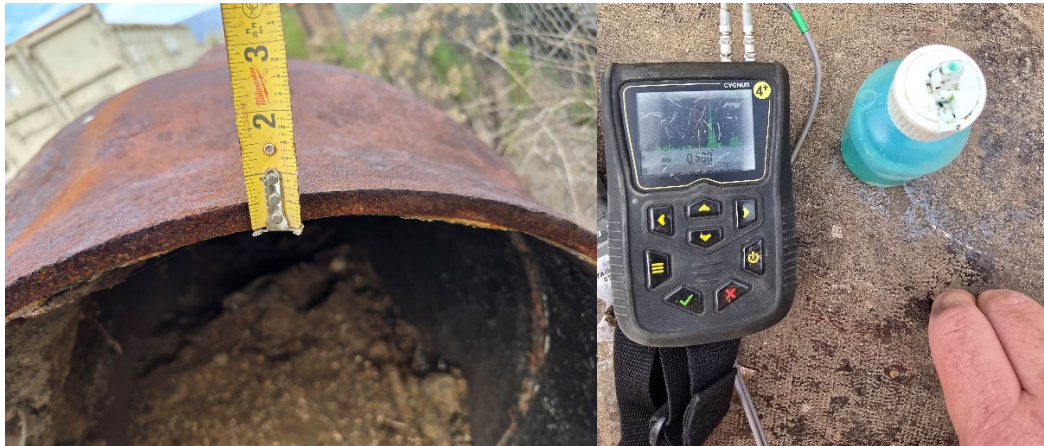
Figure 5. Nominal thickness field measurements

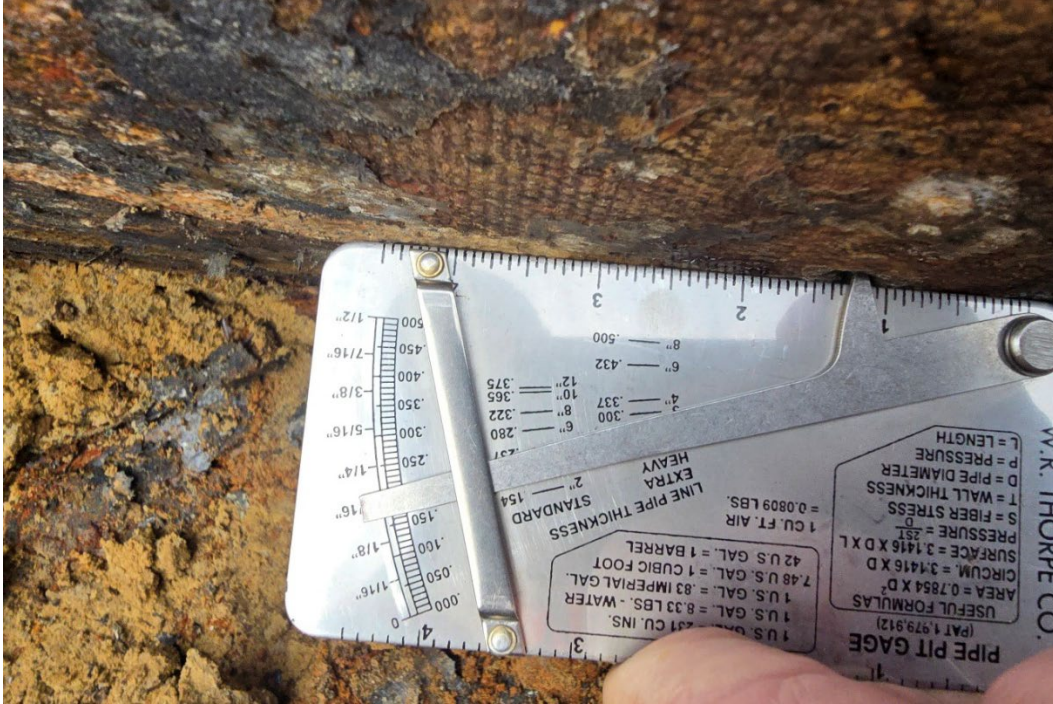
Figure 6. 0.150 inch pit found at STA 71+00

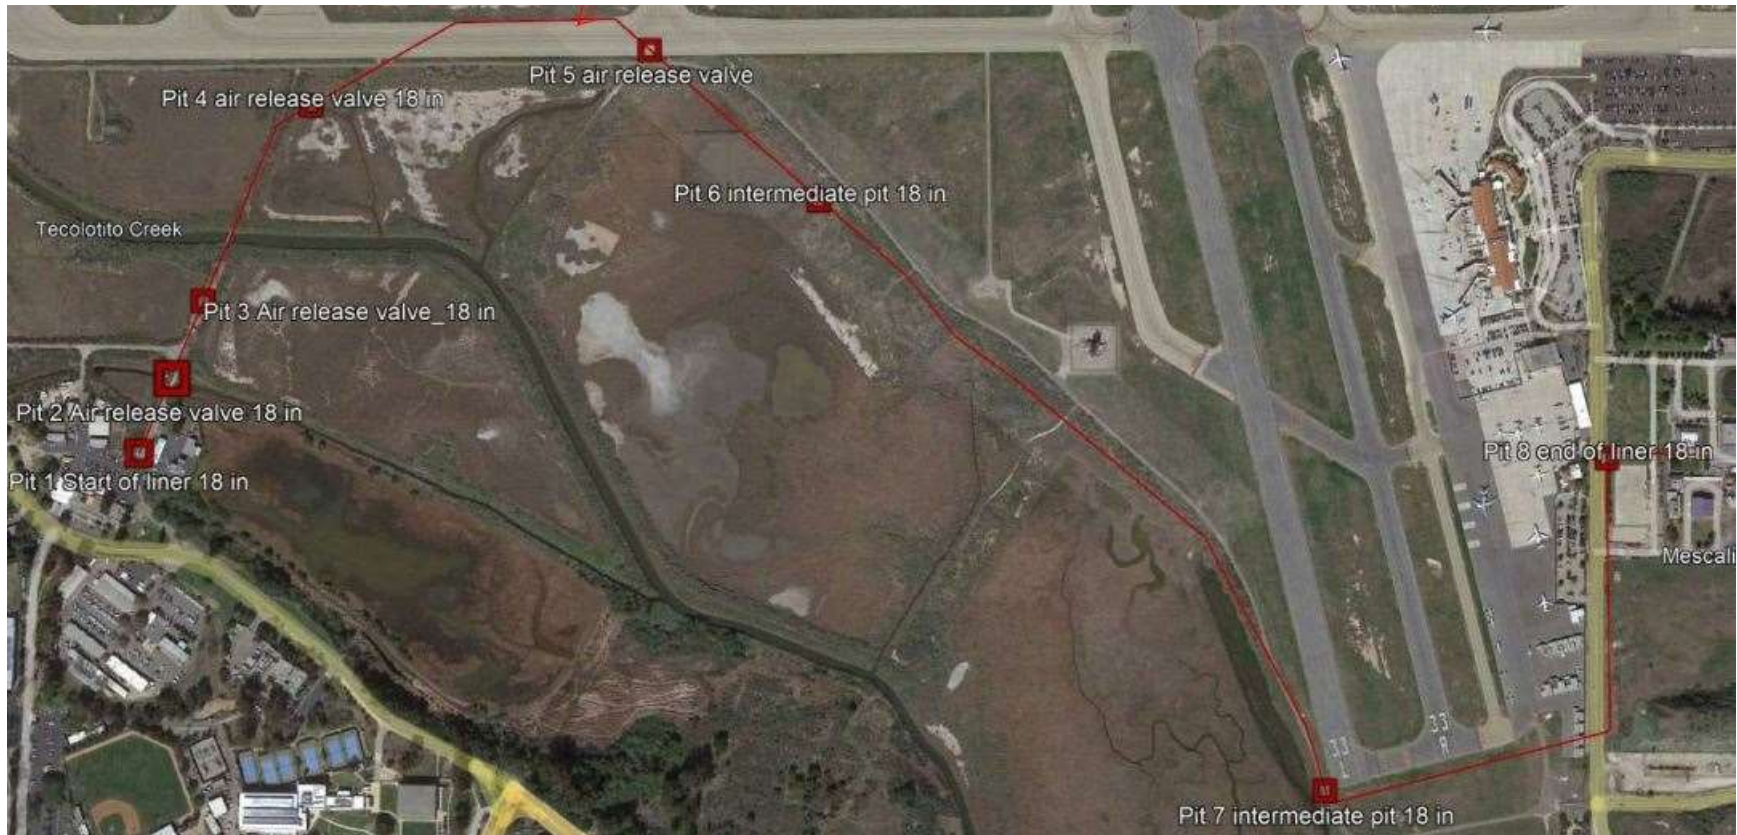
Figure Source: Draft Wastewater Force Mains Condition and Lining Assessment Technical Memo prepared by MNS, dated 1/20/2023
