# Sewer System Management Plan

## 2025 Update

Sanitary Sewer Collection System (WDID #3SSO11465)

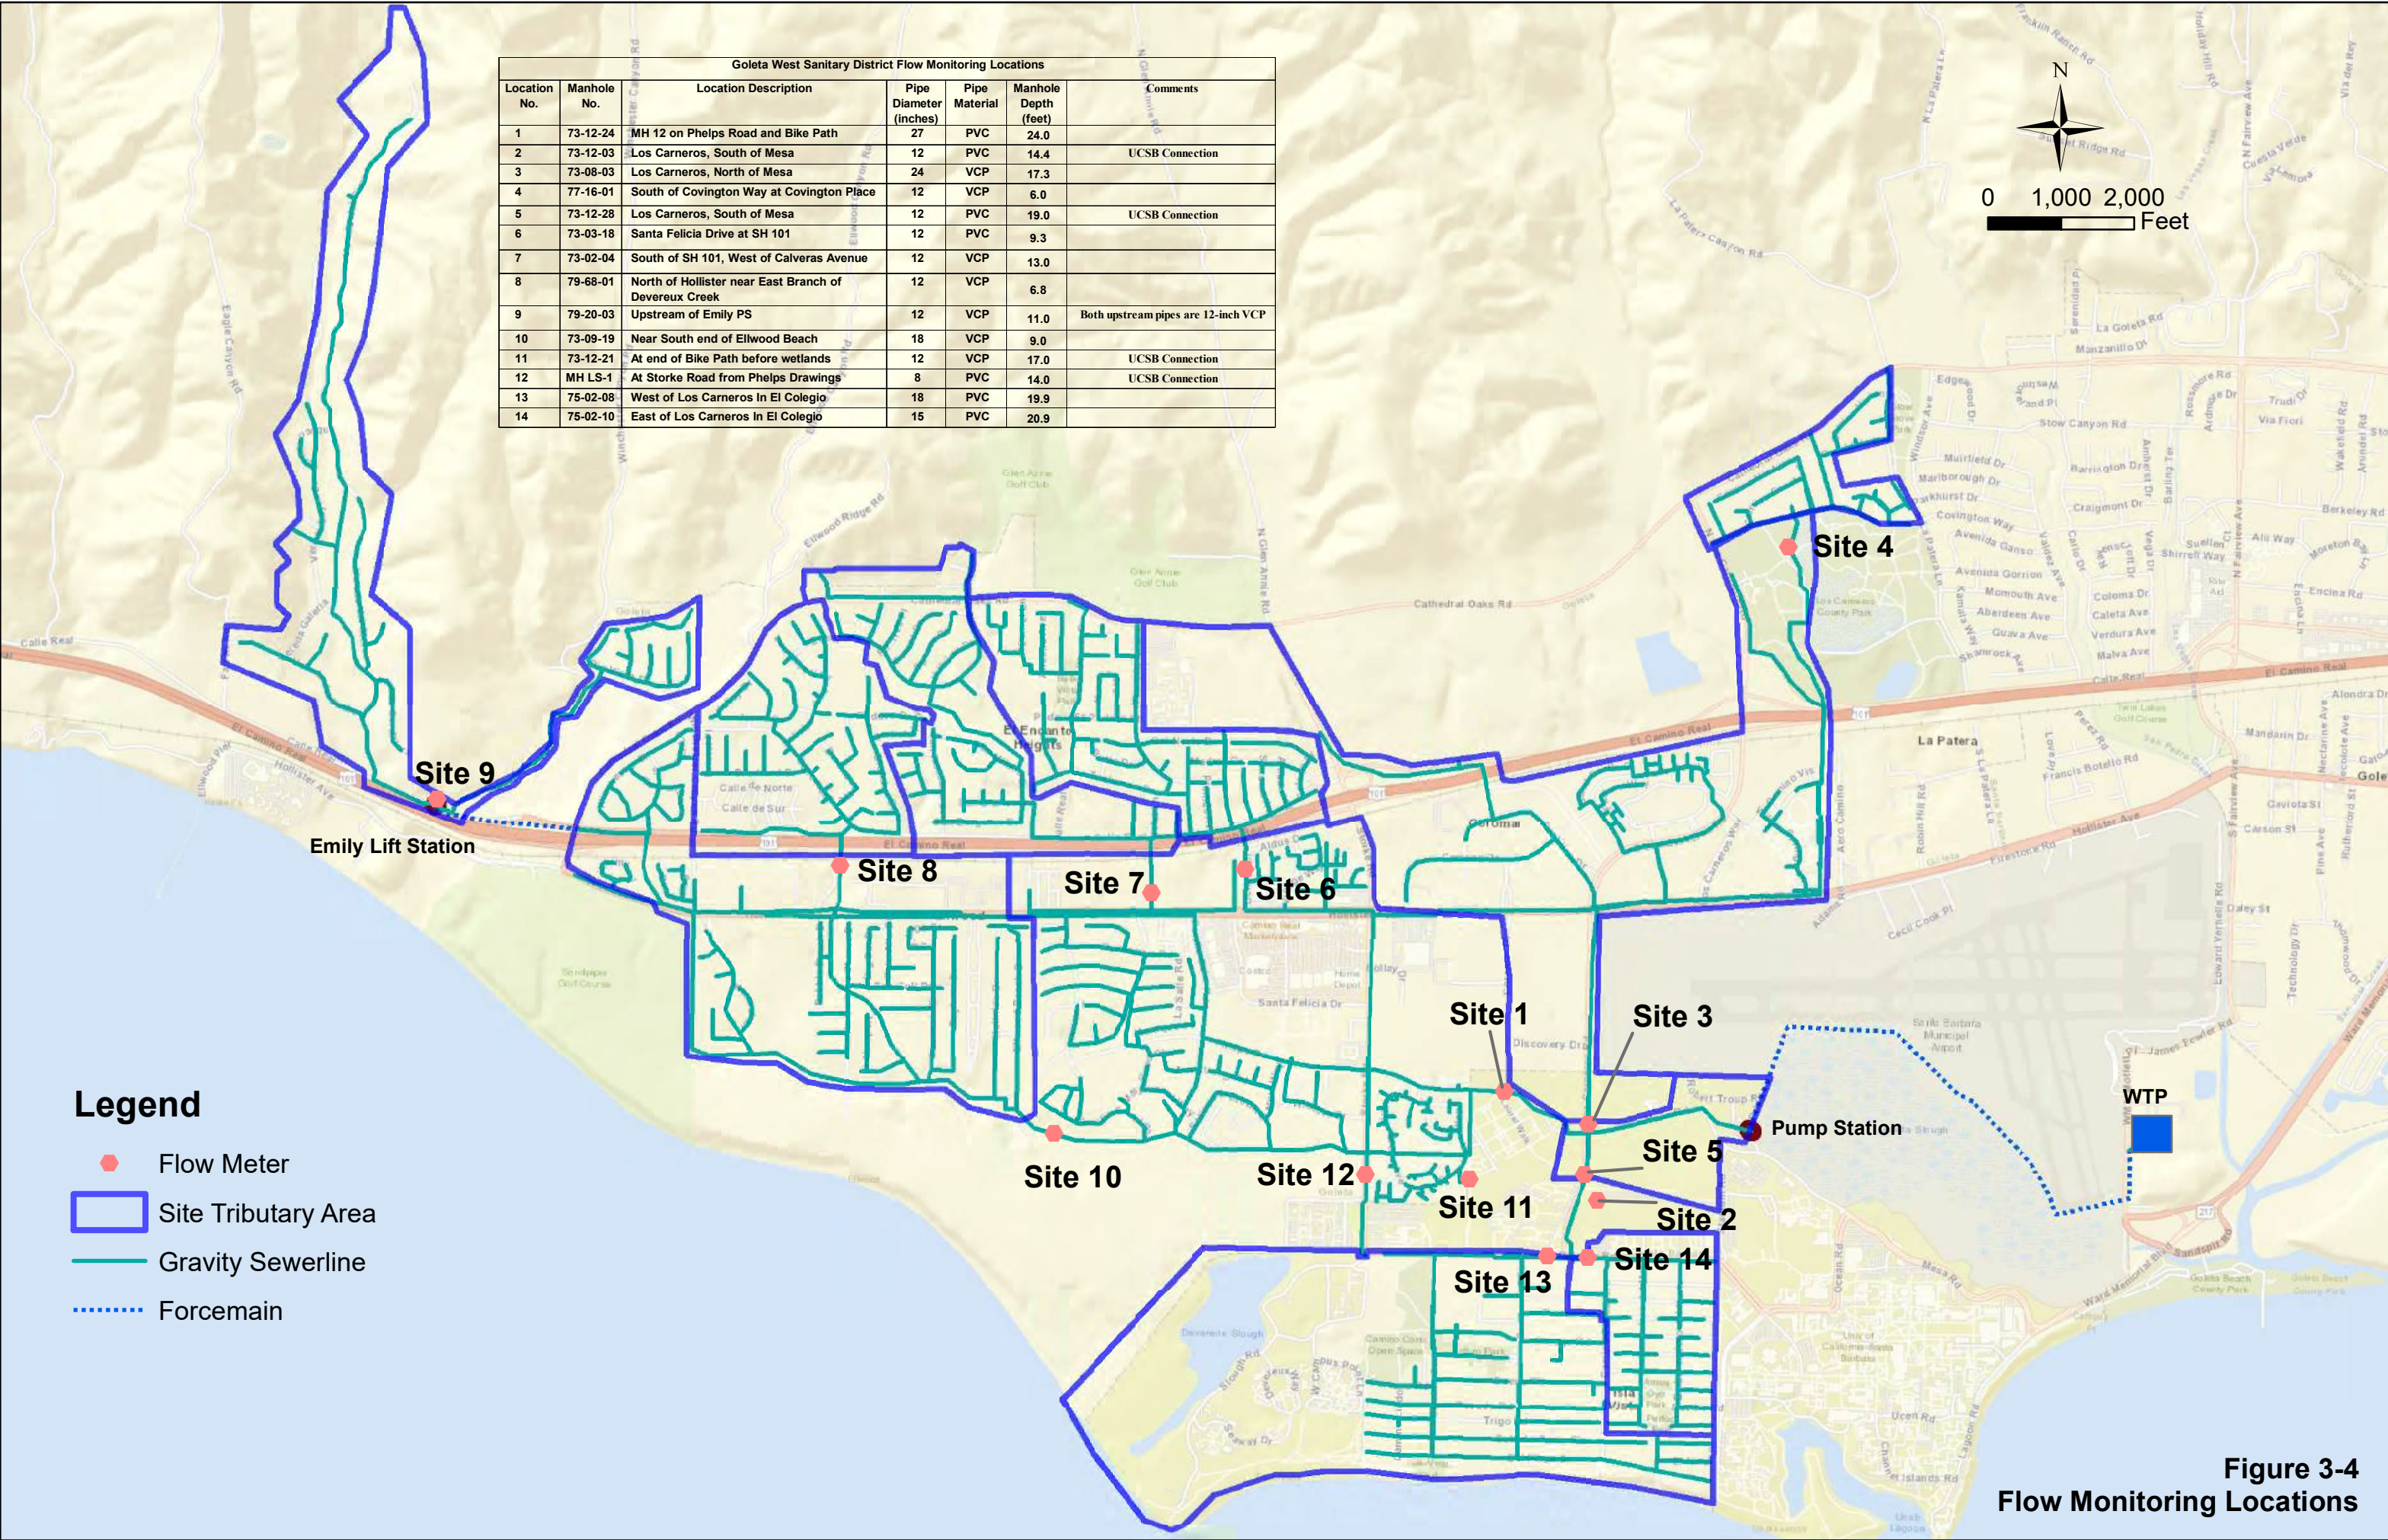
Figure 3-4  
Flow Monitoring Locations

Flow monitoring was conducted within the Goleta West system during the period of November 3<sup>rd</sup>, 2020 - January 30<sup>th</sup>, 2021. Measurements were collected from 14 locations which are shown on Figure 3-4, along with the tributary area for each flow monitor.

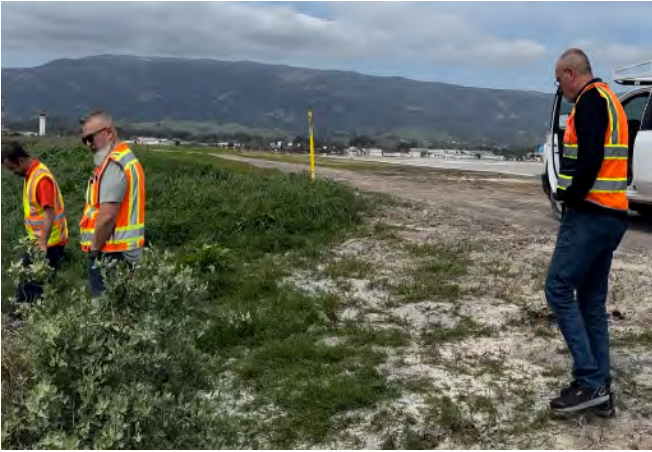
**Task B (Photo B1):** Inspection of 24-inch force main route at Feb 2024 failure location adjacent to Santa Barbara Airport, Runway 33L looking northwest (view 2).

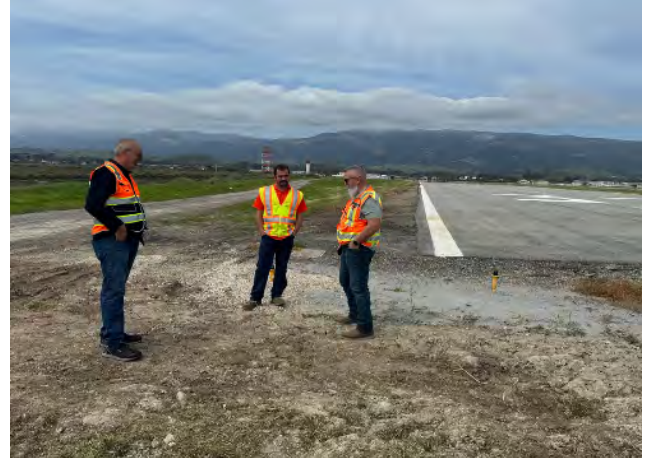
**Task B (Photo B2):** Inspection of 24-inch force main route at Feb 2024 failure location adjacent to Santa Barbara Airport, Runway 33L looking northwest (view 2).

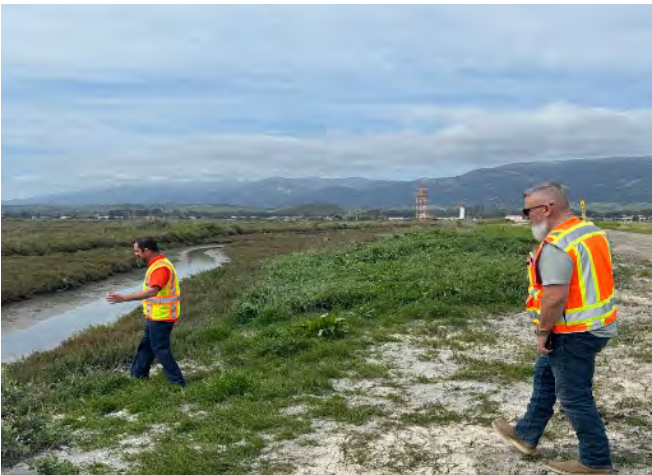
**Task B (Photo B3):** Inspection of Goleta Slough west of Runway 33L; substantial solids discharged from spill observed remaining at site (view 1).

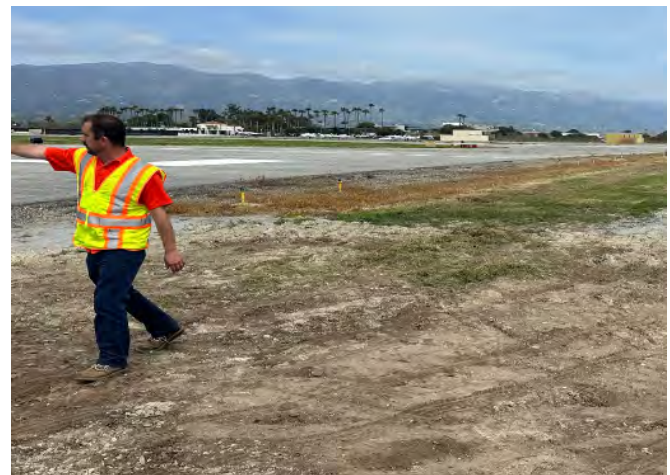
**Task B (Photo B4):** Inspection of Goleta Slough west of Runway 33L; substantial solids discharged from spill observed remaining at site (view 2).

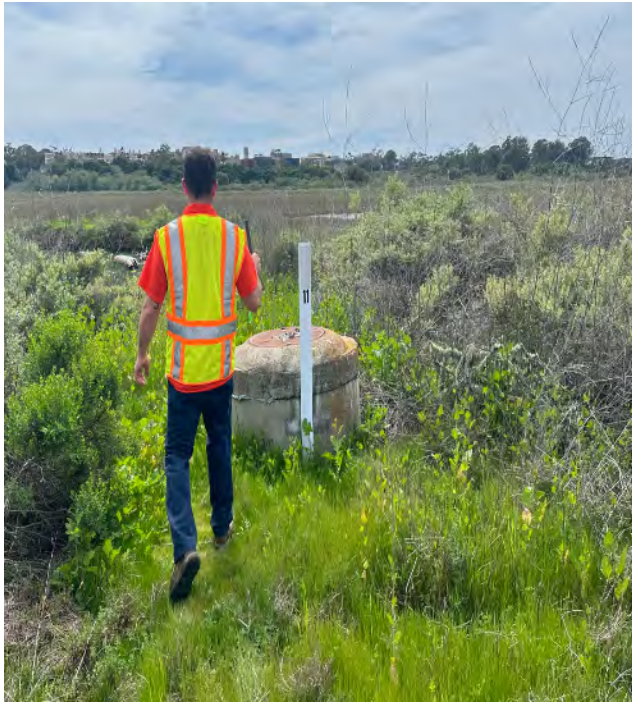
**Task B (Photo B5):** Inspection of abandoned District force main vault for air release valve (view 1).

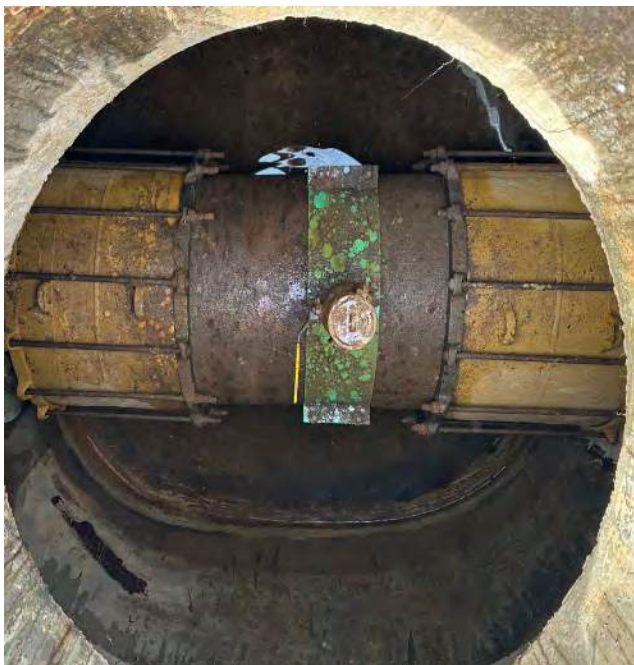
**Task C (Photo B11):** View inside District 24-inch force main sewer access vault on Santa Barbara Airport; significant corrosion observed on coupling restraining bolts and nuts.

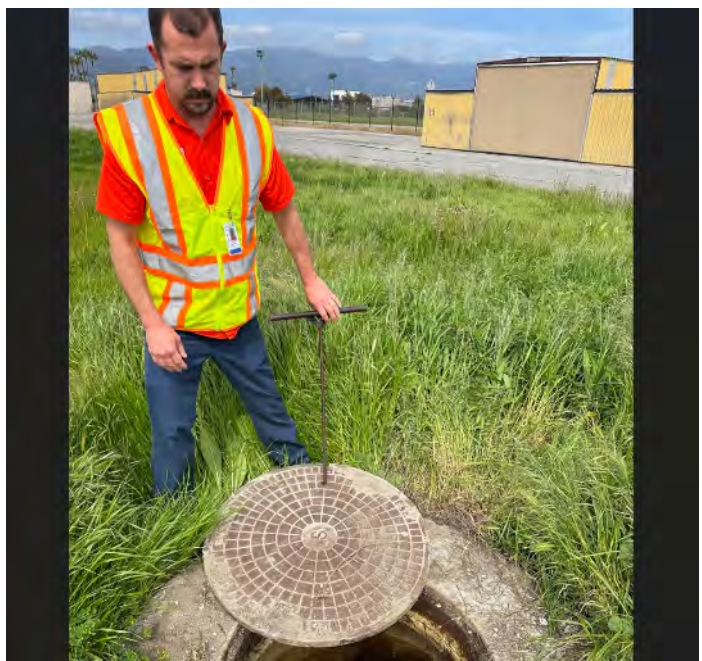
**Task B (Photo B12):** Inspection of District 18-inch force main sewer vault on Santa Barbara Airport.

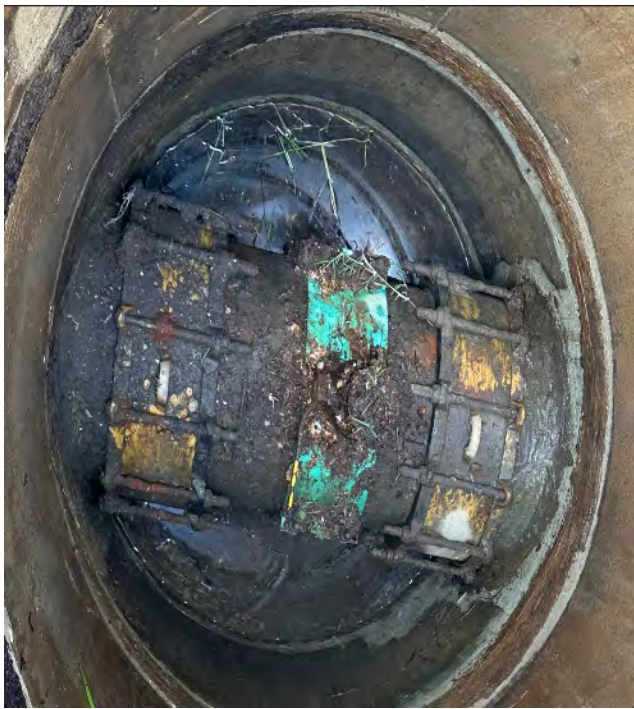
**Task B (Photo B13):** View inside District 18-inch force main sewer access vault on Santa Barbara Airport; significant corrosion observed on coupling restraining bolts and nuts.

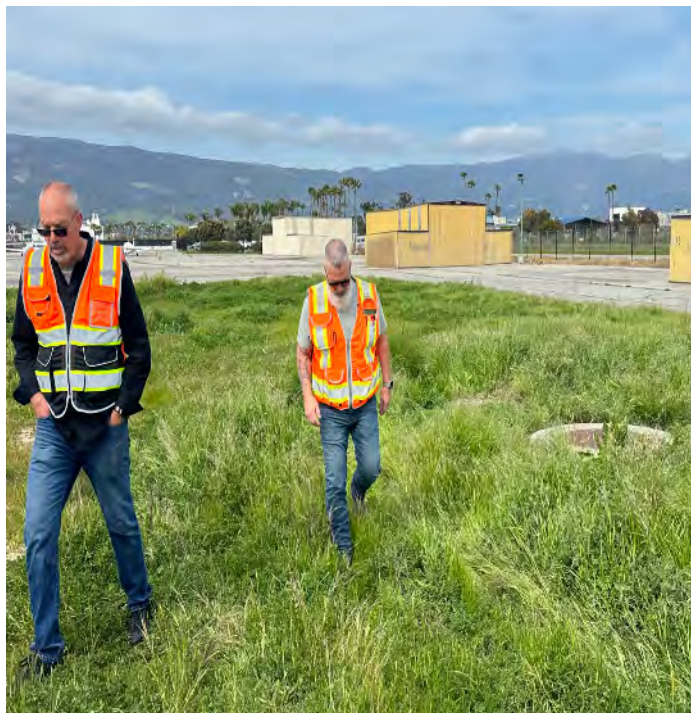
**Task B (Photo B14):** View of inspection vaults for both 24-inch and 18-inch force mains on Santa Barbara Airport looking northwest.

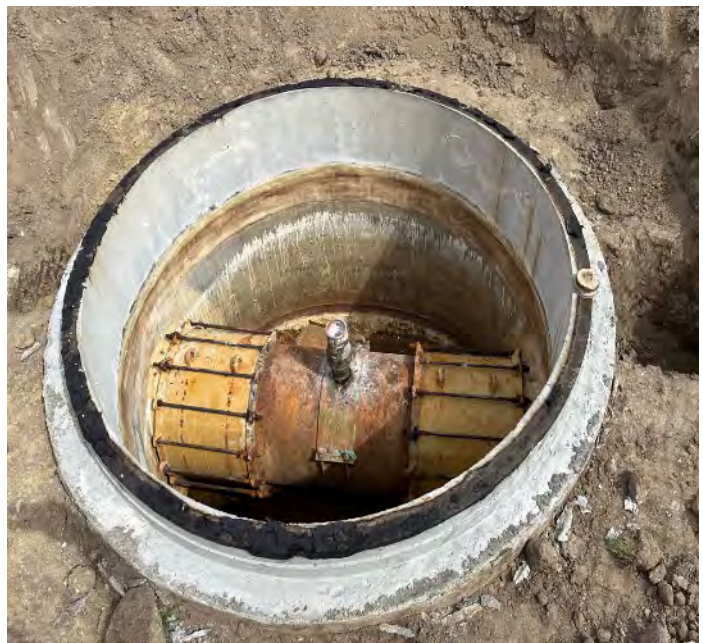
**Task B (Photo B18):** View inside District 24-inch force main sewer vault located in storage yard; significant corrosion observed on coupling restraining bolts and nuts.

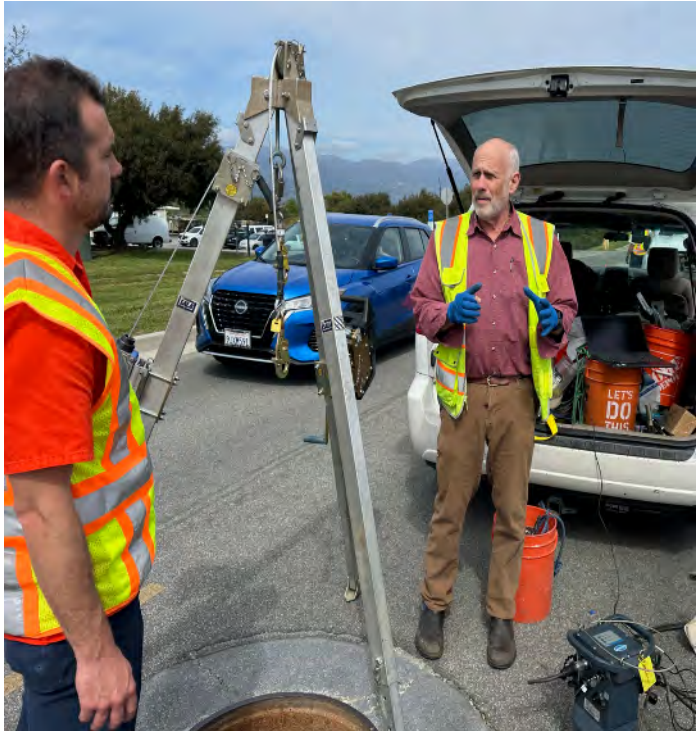
**Task C (Photo C2):** Inspection of sewer trunk line temporary flow monitoring equipment installed in manhole with District outside contractor.

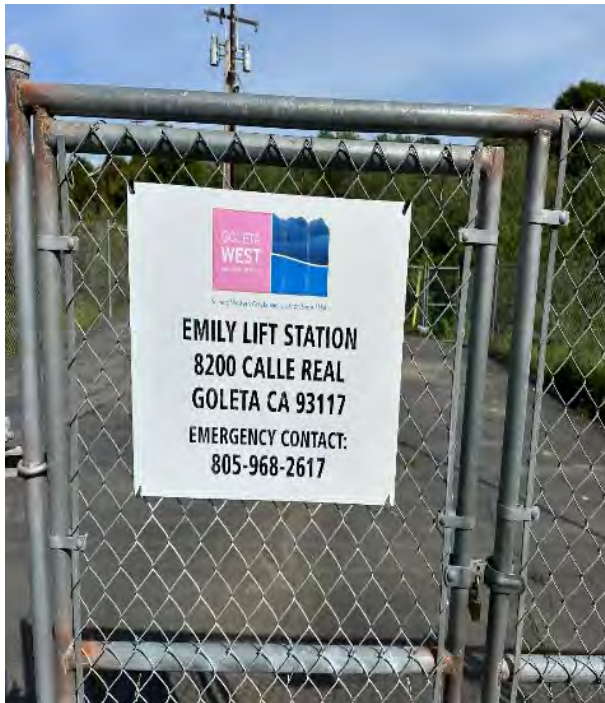
**Task D (Photo D1):** Inspection of Emily Lift Station including emergency notification signage mounted on entrance gate with District phone number.
